4 MEASURING GIRDER PERFORMANCE AND CHARACTERISTICS

4.1 Introduction

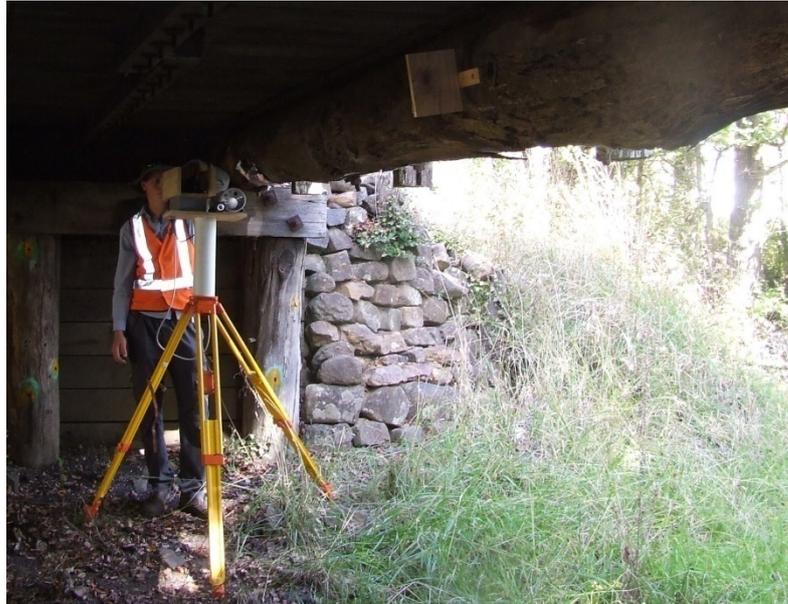
Figure 4-3: Laser and camera mounted on tripod with graduated scale mounted on girder at mid-span

The mid-span of Powers Creek Bridge was over the stream bed and scaffolding was used to enable a graduated scale to be attached to the mid-span of the main girders. The mid-span deflection was measured using a laser based method with equipment as shown in Figure 4-3. The graduated scale, in millimetre intervals, was printed on paper and mounted at the mid-span of the girder as shown in Figure 4-4. The laser was adjusted so that its quiescent position was in the vicinity of the zero line. As a vehicle crossed the bridge the girder deflected downwards and the position of the laser spot appeared to move up the chart.

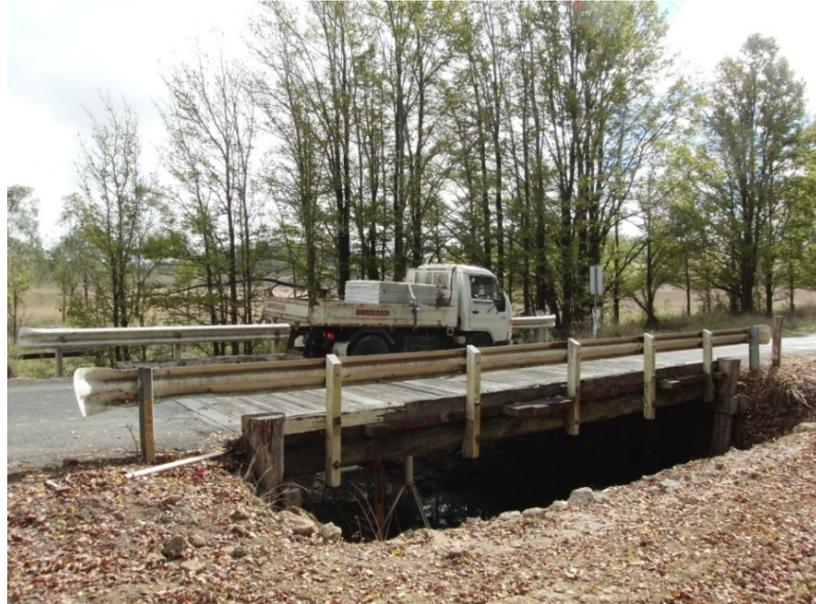
Figure 4-5: Powers Creek Bridge loaded with vehicle of approximately 4.4.tonne GVM

Five vehicles of different GVM were used to load the bridge (Table 4.1). One test vehicle is shown in Figure 4-5 parked over the mid-span and towards the left side of the bridge. Deflection data were recorded, with a vehicle stationary at the mid-span, by recording the position of the laser on the chart as shown in Figure 4-4. Five independent measurements were made for each case and the data averaged. The vehicle masses were measured on a local licensed weighbridge and the spacing of the axles recorded to enable the effective influence line to be determined. The effective load data were plotted against the average deflection data and the bridge stiffness was evaluated from the slope of the curve.

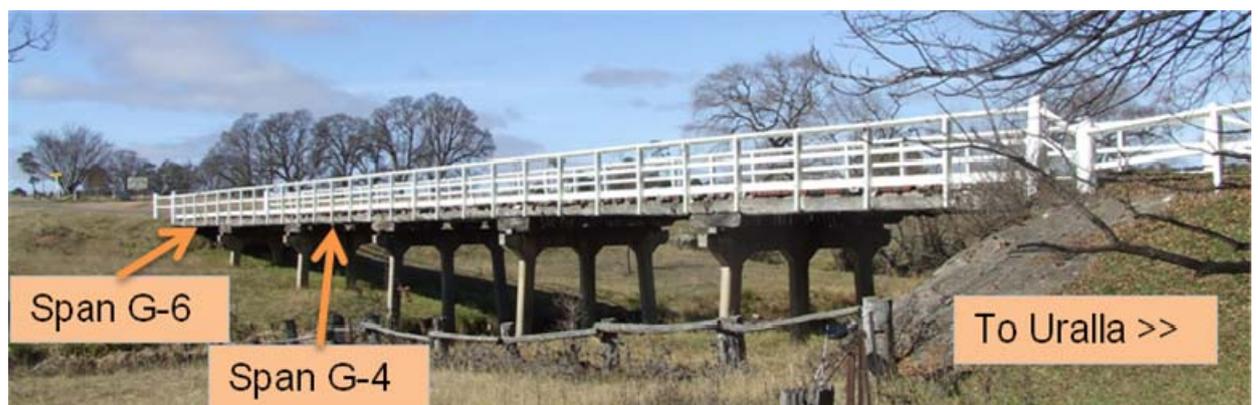
Figure 4-6: Munsie Bridge, Gostwyck, spans G-4 and G-6

The second bridge, Munsie Bridge at Gostwyck, was a six span timber beam bridge as shown in Figure 4-6. Two spans were evaluated: span G-6 and span G-4 both on the eastern side of the creek. Schematics of these two spans are shown in Figures 4-7, 4-8 and 4-9. These spans, as with Powers Creek Bridge, also comprised four girders, two central main girders and two kerb girders, which also supported a deck of timber planking. The girders, however, were supported by concrete piers and a timber capwale. Each girder span was about 10.6 m and the road width about 5.4 m.

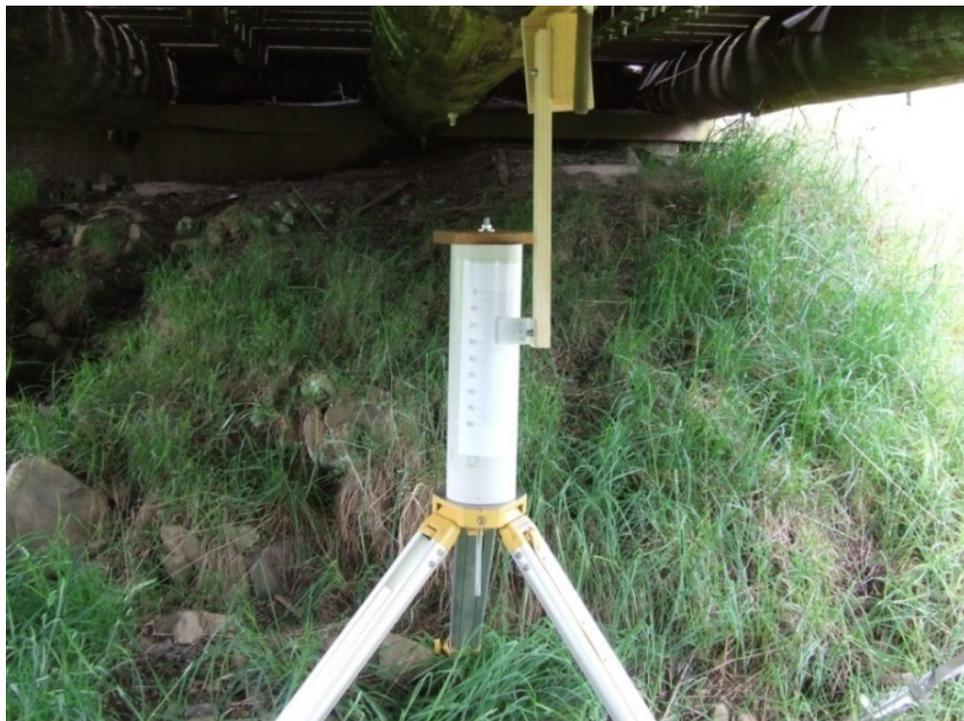
Figure 4-10: Vernier and graduated scale measuring system used at Munsie Bridge

The undersides of each span were normally accessible except in times of flooding, although scaffolding was required to access the mid-span of span G-4. The deflection was measured using a vernier together with a graduated scale as shown in Figures 4-10 and 4-11. The vernier scale was attached to a staff that was itself attached to the girder mid-span. The graduated scale was mounted on a section of 100 mm PVC pipe and supported by a tripod. The vernier was read at normal eye level, with the different girder height above ground level accommodated by different length staffs. The initial unloaded quiescent state was recorded, then the bridge loaded with a vehicle of known mass positioned over the girder. The resultant deflection was recorded. This loading was repeated five times for each loading and the data averaged. The vernier was arranged so that movements of less than 0.5 mm could be measured.

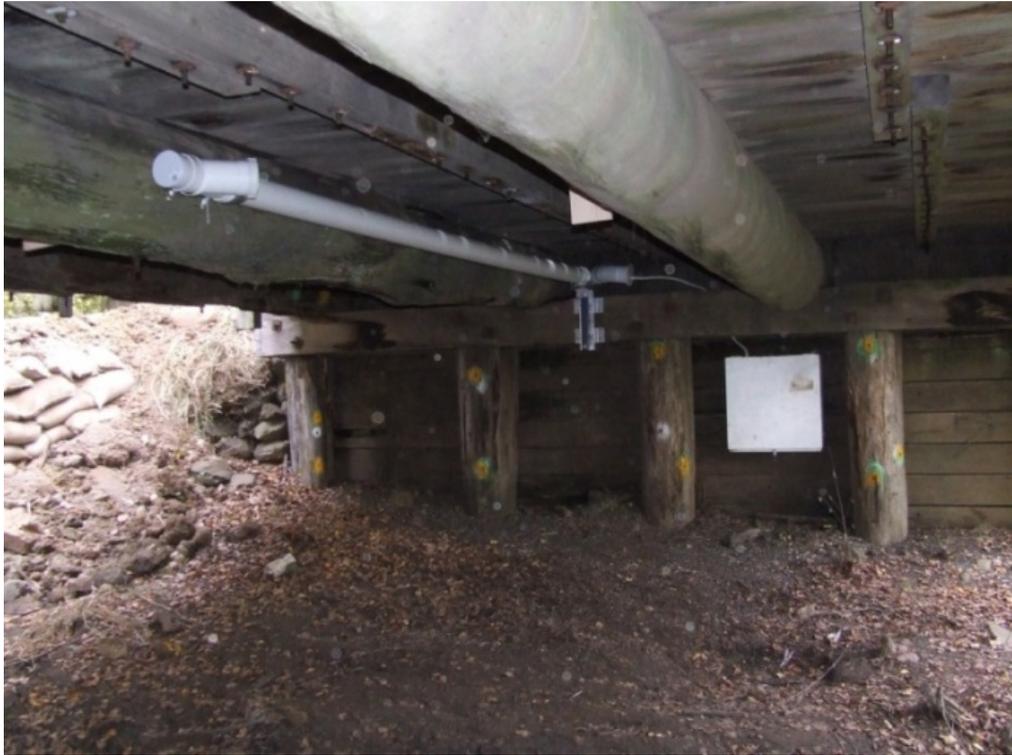
Figure 4-21: Bridge Deflection Meter attached to downstream main girder of Powers Creek Bridge

A Bridge Deflection Meter (BDM) was applied to a centre girder to record the deflections caused by traffic activity on the bridge. In this experiment the BDM laser source was rigidly attached to the headstock using a purpose-built mounting bracket and the detector attached to the mid-span of the girder with circular support clamps, as shown in Figures 4-21, 4-22 and 4-23. On Powers Creek Bridge, the BDM was mounted on the downstream main girder (PC-MD), on Munsie Bridge span G-6 on the upstream main girder (G6-MU) and on the span G-4 downstream main girder (G4-MD). The peak deflection produced by each vehicle crossing the bridge was logged electronically, together with the time that the deflection occurred. Data were recorded for a period of about three weeks on each of the three spans. Recording on Powers Creek Bridge was

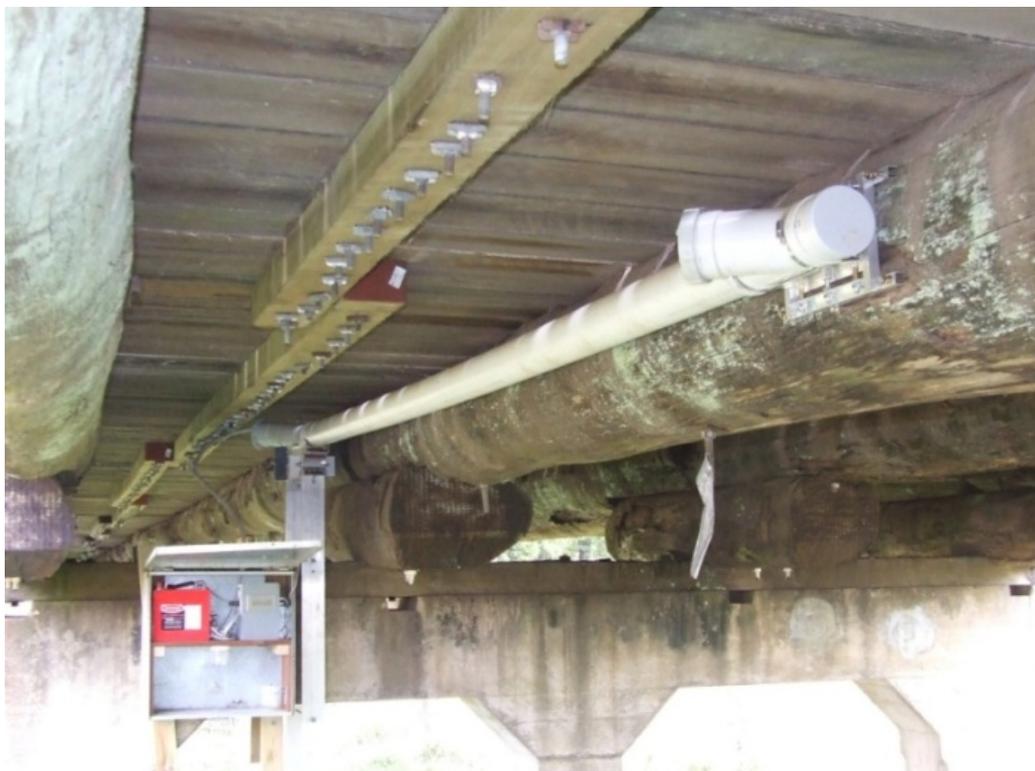
Figure 4-22: BDM attached to centre girder of span G-6, Munsie Bridge

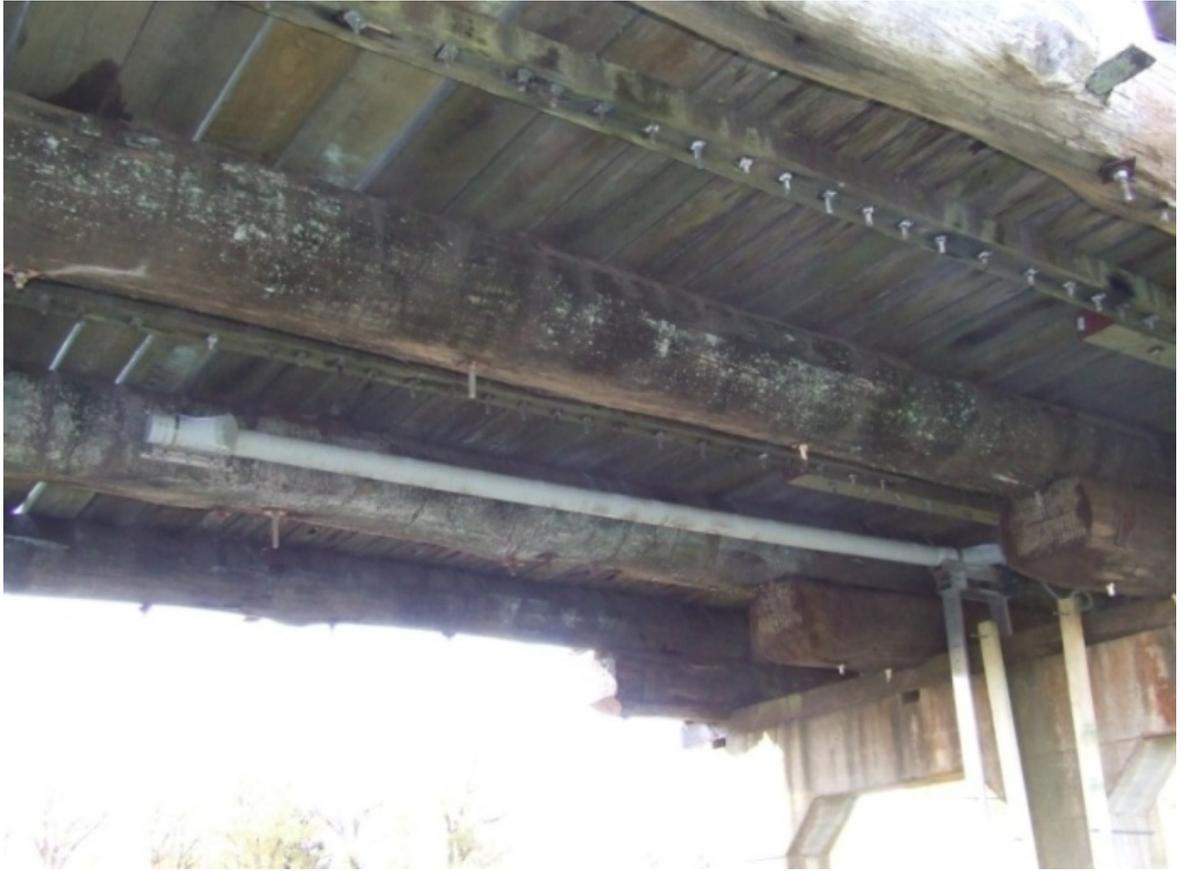
Figure 4-23: BDM attached to centre girder of span G-4 of Munsie Bridge

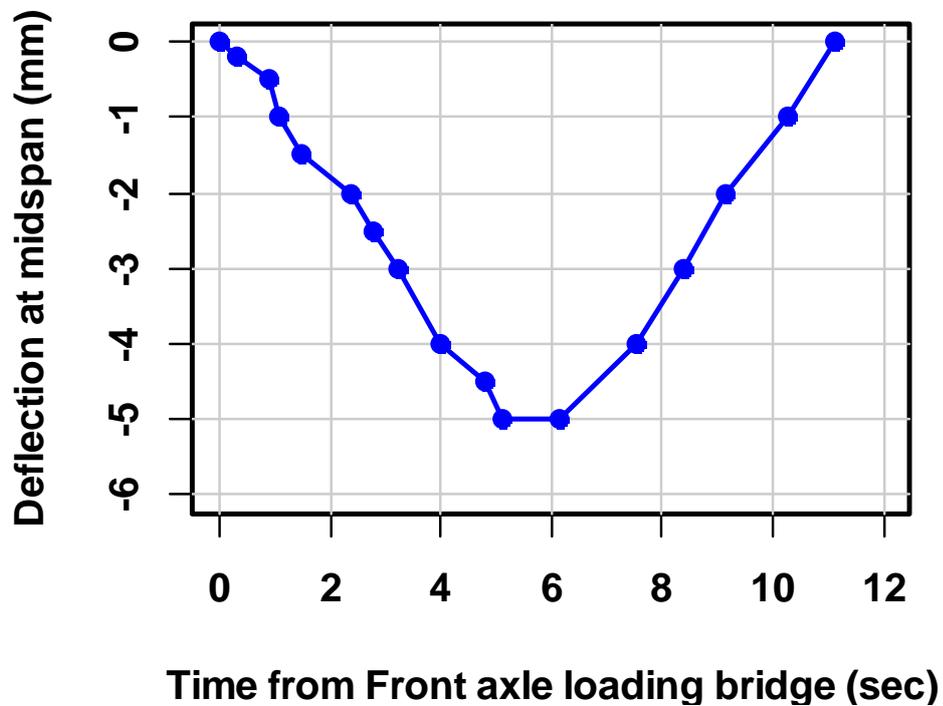
Figure 4-27: Deflection-v-time for light truck traversing Powers Creek Bridge

Time (sec)	Deflection (mm)	Time (sec)	Deflection (mm)
0.00	0.0	4.00	-4.0
0.30	-0.2	4.79	-4.5
0.91	-0.5	5.10	-5.0
1.06	-1.0	6.13	-5.0
1.50	-1.5	7.54	-4.0
2.36	-2.0	8.39	-3.0
2.78	-2.5	9.17	-2.0
3.22	-3.0	10.26	-1.0
		11.14	0.0

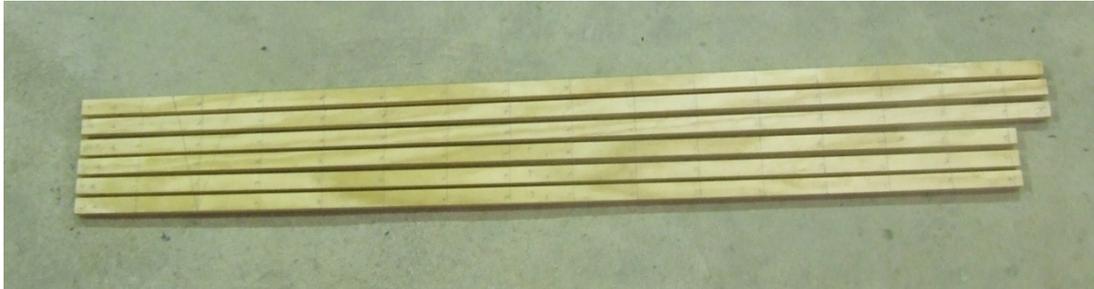
Figure 4-36: Pine samples #1 to #6

A sample pine (*P. radiata*)scantling was sawn into six samples of equal width and depth: 25.6 mm wide and 19.2 mm deep (refer Figure 4-36). These samples were two-point loaded in a bending press (refer Figures 4-37 and 4-38) to establish characteristic load-v-deflection curves. Samples were loaded both in the ambient environment and in a controlled moisture environment.

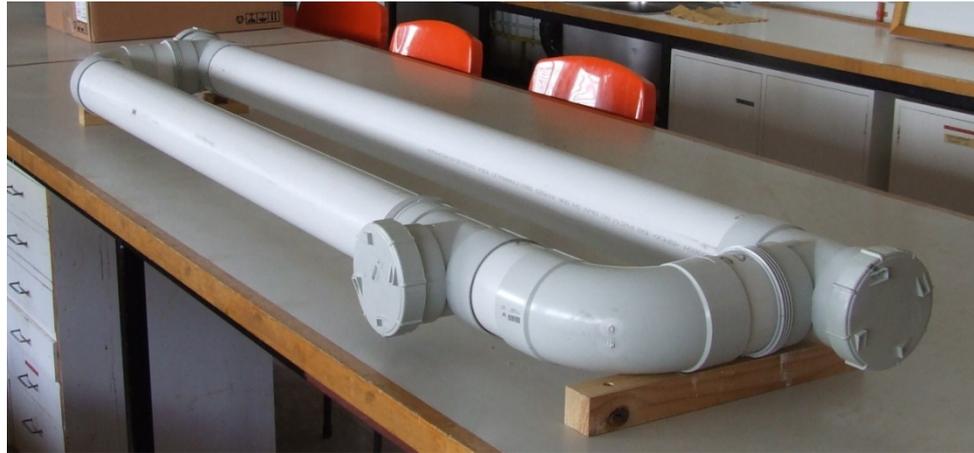
Figure 4-39: Constant humidity chamber

The controlled moisture environment was achieved by placing the samples in a constant humidity chamber of about 50% RH, controlled by salt solution and a fan (Figure 4-39). The MC of the samples was verified to be constant by re-weighing them several times throughout the experiment. While outside the chamber the samples were wrapped in plastic film to ensure that their moisture content did not vary significantly during measurement.

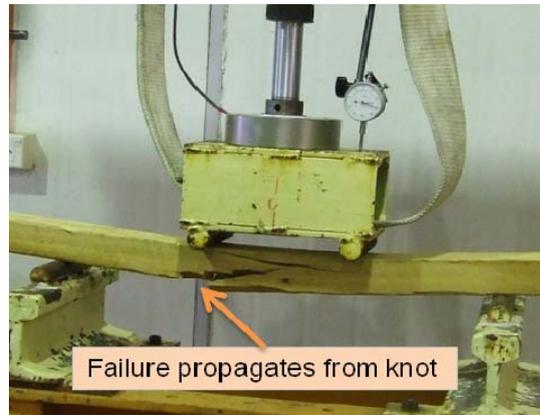
Figure 4-44: Cypress pine sample at failure

The sample immediately after failure is shown in Figure 4-44. The failure has been initiated in the vicinity of the knot that is identified in Figure 4-42. The failure was sudden. This is reflected

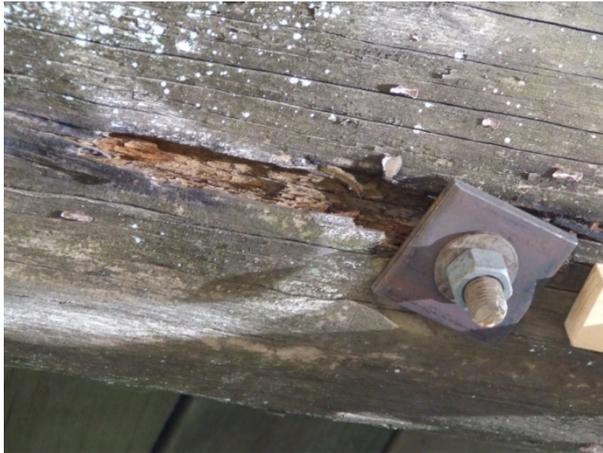
Figure 5-10: Evidence of decay in the main upstream girder, Munsie Bridge Span 4, at mid-span

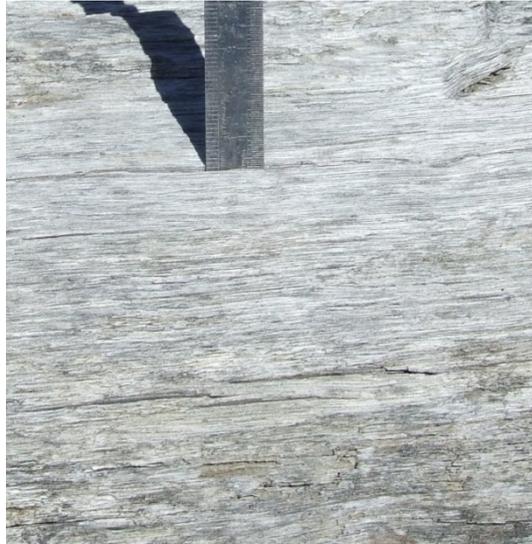
Figure 5-32: Girder checking, low incidence with occasional 3 mm checks
