# 1 INTRODUCTION

**Continuous deflection monitoring can be used to assess  
the probability of timber-bridge girder failure**

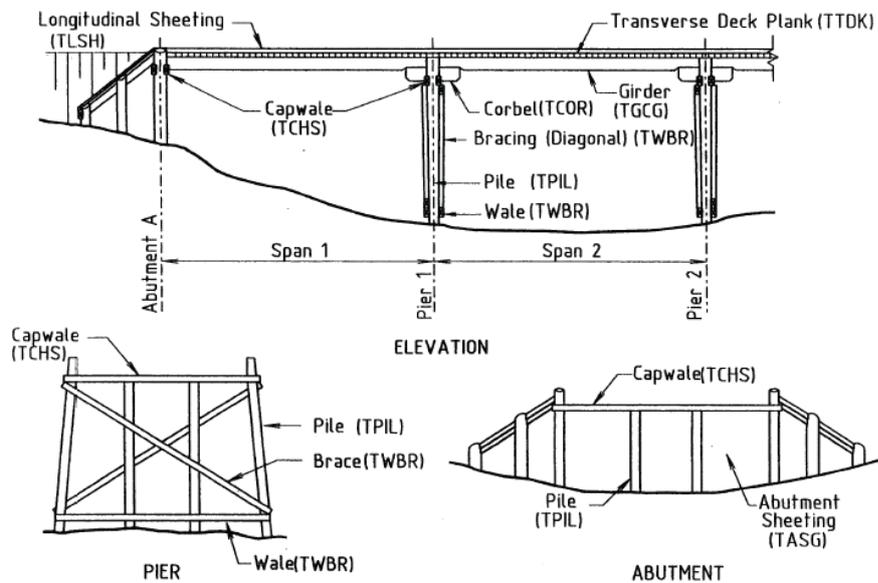
Figure 2-1: Schematic of multiple span timber beam bridge (RTA, 2007: Sketch No. 11)

There are many thousands of timber beam bridges in Australia with about 2000 extant in NSW (Howard, 2009; Roorda, 2006). Timber-bridges are constructed in a variety of forms, so to ensure that these bridges are known to be structurally sound, it is important to quantify the strength of the major structural elements. A general outline of a timber-bridge is shown in Figure 2-1 (RTA, 2007). Some bridges have: multiple spans; some are only single span; others are high level spans that are above normal flooding as suggested by the outline in Figure 2-1; while some are low level as in Figure 2-2. However, one major structural element that is common to all timber beam bridges is the girder.

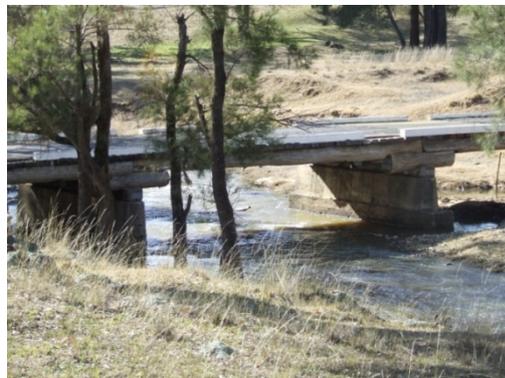
Figure 2-2: Gwydir River Bridge, Bundarra, NSW. This is a low-level timber beam bridge, but typical of many throughout NSW on local roads

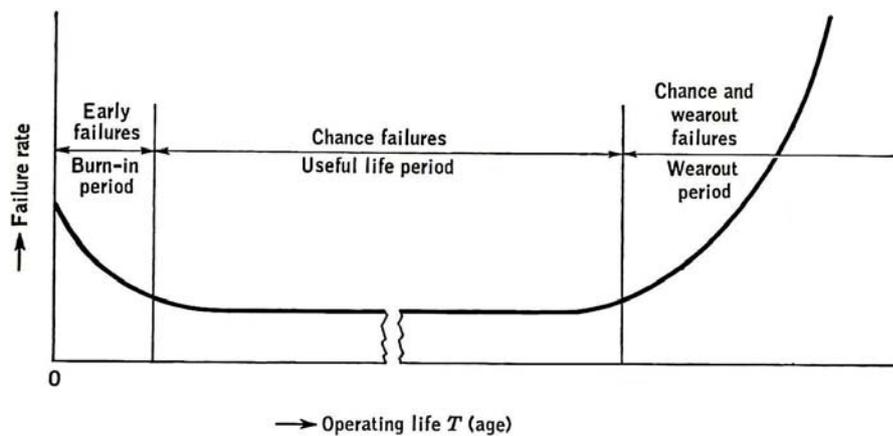
**Figure 2-3: Component failure rate-v-time, adapted from Bazovsky (1961, Figure 5.1)**

lifetime is that as checks and pipes develop in a girder, they can combine within a short period and reduce component lifetime below expectations (refer Sections 2.4.1 and 2.5.3).

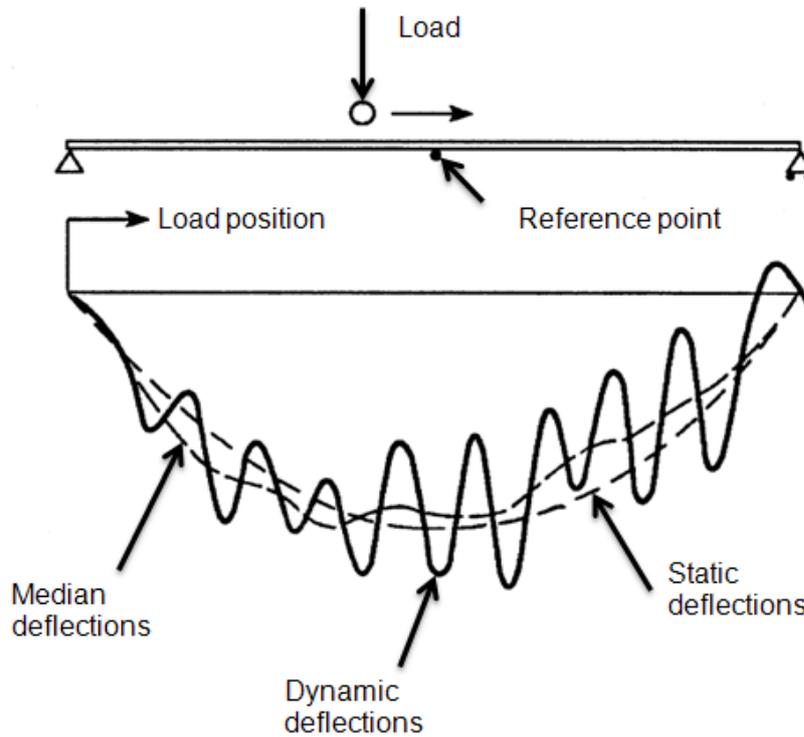
Figure 2-4: Mid-span girder deflections under a moving load, adapted from (Bakht & Pinjarkar, 1989: Figure 1)

Moving vehicles impose increased forces and stresses on a bridge girder. These increased forces cause increased deflections (Biggs, Suer, Louw, Engineering, & Works, 1956; Fuller, Eitzen, & Kelly, 1931; Mufti, 2001). Mufti (2001) recently summarised the usage of terms related to dynamic deflection using a diagram by Biggs et al. (1956). A simplified form of that diagram is repeated here as Figure 2-4. A reference point placed at the mid-span of a bridge will deflect in response to a load that is moved across the bridge. A static load placed on the bridge and displaced incrementally across the bridge will produce the deflections shown as the curve labelled *Static deflections* in Figure 2-4. If a load is moved continuously across the bridge, any unevenness in the surface will cause the load to move up and down. This is reflected in the measured response and an example is shown in Figure 2-4 labelled *Dynamic deflections*. By averaging the measured response data an intermediate response is obtained, identified as the curve annotated *Median deflections* in Figure 2-4.

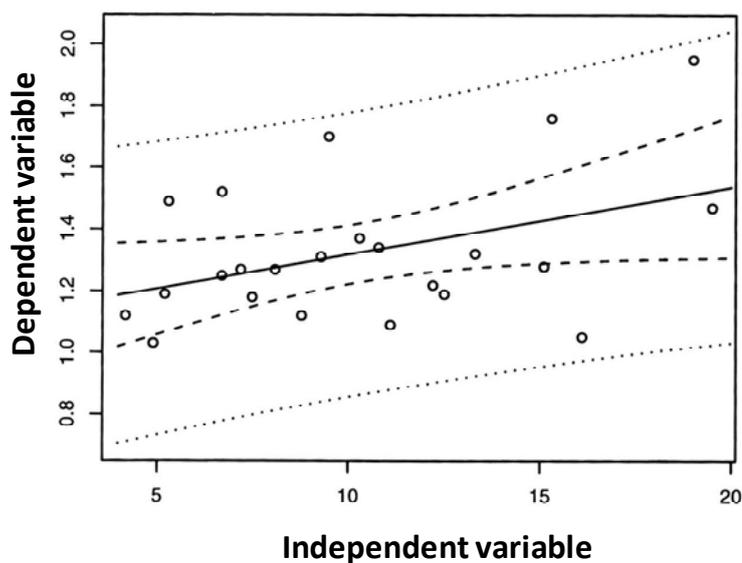
Figure 2-5: Sample linear regression with prediction confidence bands, adapted from Dalgaard (2008, p. 121)

The next predicted value of the dependent variable is contained within and between the outer dotted lines of Figure 2-5 to a confidence level of 95%; two standard errors from the mean. The important features to note from the curves in Figure 2-5 are that both standard errors depend on the value of the independent variable and that the variances increase quadratically as the independent variable moves away from the mean value,  $\bar{x}$ . The regression line prediction band is thus limited by the dashed lines to a 95% confidence level and the next predicted individual value is limited by the dotted line prediction band to a 95% confidence level.

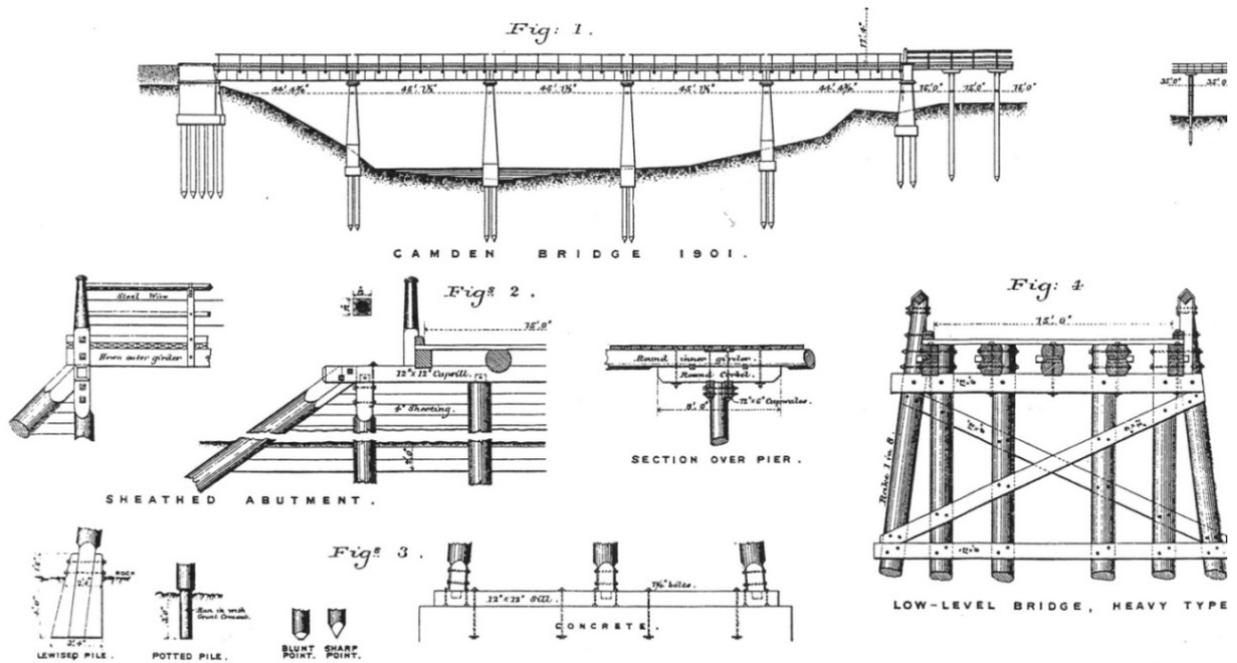
Figure 2-7: Plans for Camden Bridge, ca. 1901 (Dare, 1903)

A characteristic timber beam bridge design of this period is shown in Figure 2-7. What is surprising about this design is firstly that there are many thousands of timber-bridges that are of similar basic design that remain in service carrying modern vehicle loads and traffic volumes (Howard, 2009; Roorda, 2006); and secondly, that the design has not varied significantly from the original. Indeed, Newell (1938) reported that this basic design had been around since the early 1860s.

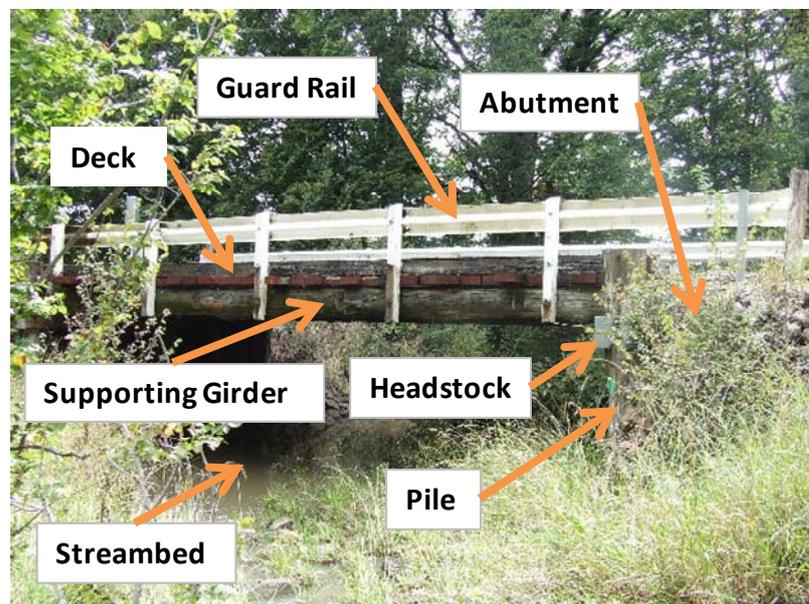
Figure 2-9: Single span timber-bridge (Powers Creek Bridge, 1930 – 2011)

Other features of recent design standards are also more demanding. AS 5100.2 also specifies the design life as, “... the period assumed in design for which a structure or structural element is required to perform its intended purpose without replacement or major structural repairs” (Standards Australia, 2004a, AS 5100.1, Section 4.2). It is also specified that the design life of structures to be 100 years (Standards Australia, 2004a, AS 5100.1, Section 6.2). Such a period without significant structural repair is a very demanding criterion. The bridge shown in Figure 2-9 has lasted about 80 years, but it has been structurally repaired many times during its life. These repairs have involved the replacement of several of the major components. This bridge across Powers Creek on Dangersleigh Road, 10 km south of Armidale NSW, comprised four supporting girders and had a timber deck comprising cross-decking at least 100 mm thick. A longitudinal view of this bridge is shown in Figure 2-10.

A timber-bridge can be a single span structure or it can consist of many spans. An example of a single span structure was Powers Creek Bridge, shown in Figure 2-9. An example of a multiple span structure, Munsie Bridge, is shown in Figure 2-15. Munsie Bridge is situated about 10 km east of Uralla, NSW, over Salisbury Waters at Gostwyck. Each span consists of four 10 m long girders mounted on and bolted to the corbels. The piers are concrete with a timber headstock and as with the Powers Creek Bridge the decking is cross-planking. In contrast to the Powers Creek Bridge deck, which was relatively smooth and allowed vehicles to cross at 100 km h<sup>-1</sup> the Munsie Bridge deck is uneven (varying thickness and varying degrees of fastening) and traffic crosses at low speed.

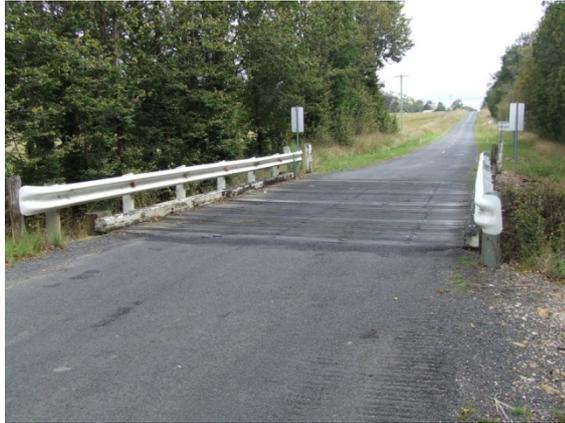
**Figure 2-10: Longitudinal view of Powers Creek Bridge**

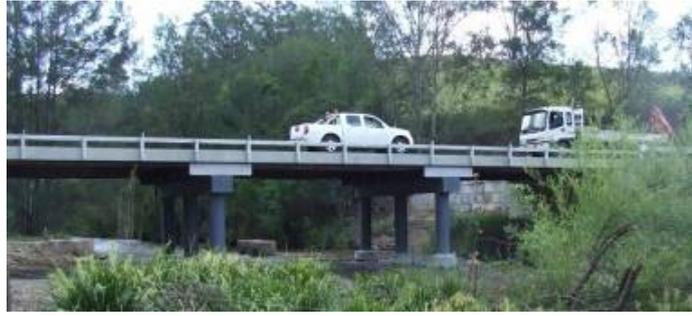
**Figure 2-12: The replacement high Level composite steel/timber/concrete bridge (Leslie’s bridge)**

Although the majority of Australian timber-bridges are similar to those designed by ‘pioneering’ engineers such as McDonald, Allan and Dare, there have been some later designs, such as the composite timber and concrete structures built in Tasmania (Nolan, 2006) and more recently in Gloucester Shire, NSW. An example of this latter structure is a bridge constructed in 2010 to replace Leslie’s Bridge across the Little Manning River near Brett on Thunderbolts Way, between Gloucester and Walcha (Roads and Maritime Services, 2012). The original bridge was a single lane low-level timber-bridge of two spans and susceptible to flooding (Figure 2-11). The replacement structure comprised a monolithic concrete deck supported on round timber girders and corbels, which are in turn supported by a steel substructure fixed to reinforced concrete footings (Figure 2-12). The former bridge was below the normal flood level and occasionally inundated, whereas the new structure has a much lower probability of overtopping by flood waters. Thus, the replacement structure has improved the level of service to traffic in the area by providing a greater level of access and an improved approach alignment.

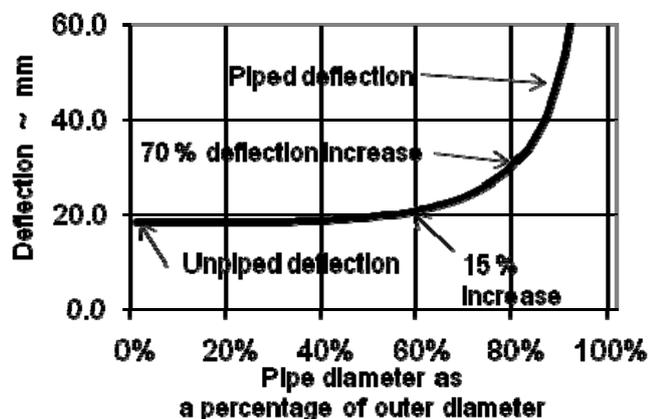
Figure 2-13: Effect of piping on deflection while under constant loading conditions (Moore et al., 2009, Figure 1)

The level of piping in new girders is low and, if less than about 20% of the cross-sectional area, should not significantly reduce girder strength unless severe checking is present (as an example refer Figure 2-22, page 36). It is not until the piping percentage reaches around 60% of the cross-sectional area, or more, that the mid-span deflection is significantly affected. At 60% the mid-span deflection can increase by several millimetres; a measureable amount. The nominal deflection that might occur in a girder for a constant outer diameter pipe is shown in Figure 2-13 (Moore, Glencross-Grant, & Patterson, 2009).

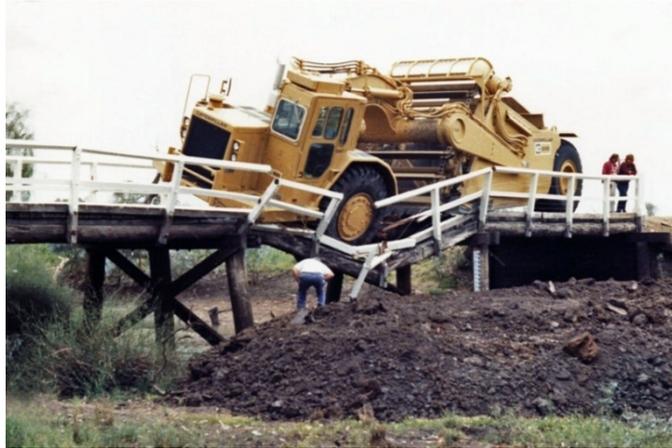
**Figure 2-14: Example of structural overload on a timber beam bridge, with catastrophic failure of a kerb girder, c. 1975 (Photo: R. Glencross-Grant)**

There are many timber beam bridges still in service that have followed this concept and have been designed with kerb girders that are of smaller diameter than the central main girders. However, with today’s heavy vehicles this type of design can lead to unexpected overloads. The structural failure shown in Figure 2-14 was initially caused by the failure of timber decking. This failure caused a shift in the centre of gravity, thus transferring excessive load to the kerb girder, which then failed. The failure may also have been exacerbated by the driver of the vehicle not driving centrally across the bridge. It is interesting to note that only the kerb girder failed, the vehicle was still supported by the central girders. If the load had been better supported by the two central girders, by virtue of a narrower wheelbase or a multiple wheel low loader, the failure would probably not have occurred.

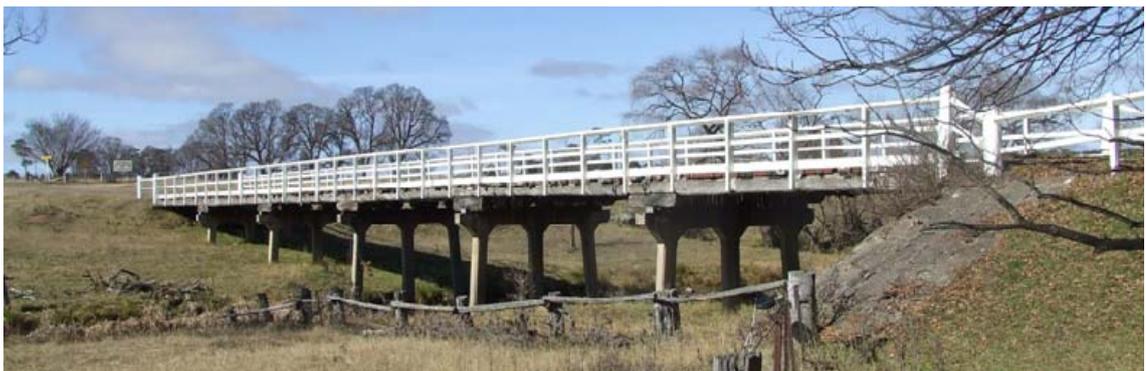
**Figure 2-15: Munsie Bridge, Gostwyck - an example of a multiple span bridge**

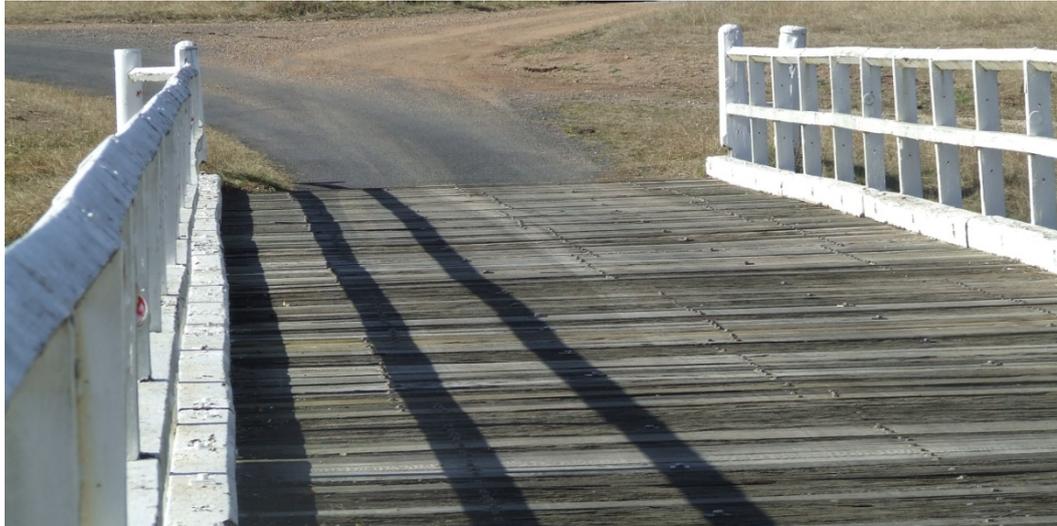
**Figure 2-16: Munsie Bridge- uneven timber decking**

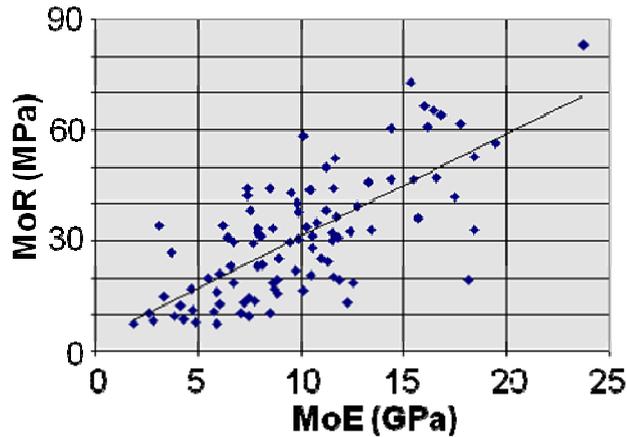
Figure 2-17: MoR-v-MoE data for Tasmanian timber-bridge girder, adapted from Yttrup & Nolan (1996, Figure 4)

Statistical data provided by UTas included a regression equation ( $\text{MoR} = 3.36 + 2.79 \times \text{MoE}$ ) and a coefficient of determination of 0.52. Yttrup and Nolan did not provide a prediction band for these data. What is of immediate interest in these data is that there are no values of MoR above 86 MPa; that is the S2 limit state. Although it is reported that these data are calculated without any reductions for decayed areas they are still unusually low. The species that are reported by Boland et al. (1984) as suitable for structural use in Tasmania, such as Tasmanian blue gum (*Eucalyptus globulus*), brown top stringy bark (*Eucalyptus baxteri*) and silver top ash (*Eucalyptus sieberiana*) all have values of MoR and MoE similar to other suitable species referred to in Table 2-5. Yttrup and Nolan (1996) discuss the strength of girders from the design perspective but do not explain how the MoR-v-MoE vector trajectory of these timbers moves from acceptable values to unacceptably low values. There is a temporal movement from new MoR-v-MoE values to the published aged MoR-v-MoE values but no attempt to quantify this movement. Also, from what is published about this dataset it is not clear if similar results should be expected from extant girders in NSW.

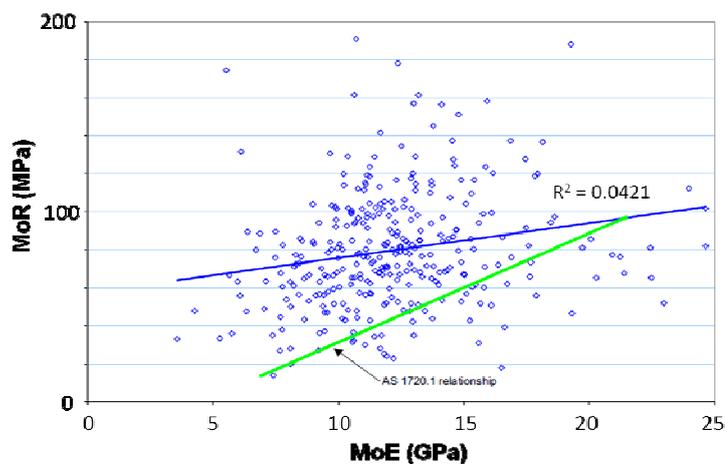
Figure 2-18: MoR-v-MoE for round timber poles, adapted from Samali et al. (2007, Figure 3)

Data were gathered as part of a project examining power poles in NSW (Crews, 1998; Decosterd, 1998; Horrigan, Crews, & Boughton, 2000). That project examined the strength of poles at the ground line and not at mid-span. It involved poles of a wide variety of ages and quality and involved a wider range of timber species than the Royal Species. The critical step in identifying the strength of timber-bridge girders is to identify whether there is a non-destructive parameter that equates to girder strength. An initial candidate parameter is MoE, which can be readily measured for an in-service girder with appropriate apparatus. Samali, Li and Crews (2007, Figure 3) present MoR-v-MoE data, which is reproduced here as Figure 2-18. The significant variation demonstrates that there is no apparent relationship between MoR and MoE (often referred to as a ‘cloud diagram’). However, what can be estimated from this dataset is that the variation of the values of MoR for degraded timber can be about 30% CV.

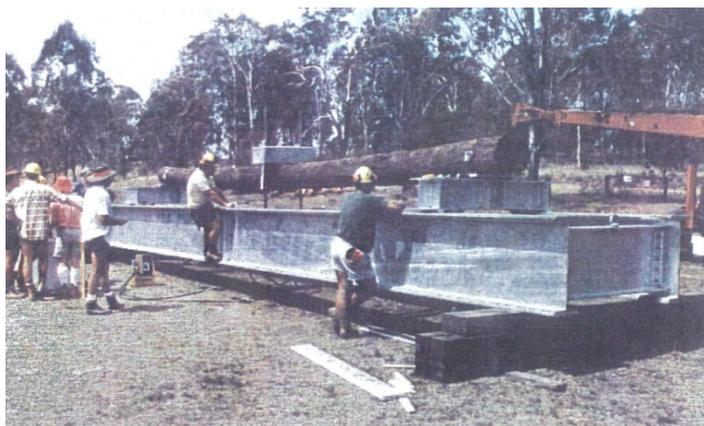
**Figure 2-19: RTA portable girder test rig showing three point loading of full-size specimens, c.1990 (RTA photo, unknown source)**

In 1990 the RTA began a girder testing program which involved testing girders from regional bridges. Full scale testing was performed in a portable test rig similar to the type shown in Figure 2-19. This testing was conducted at 20 different locations throughout NSW. Amongst the 169 girders tested there were ones of different age, species and degree of deterioration. The girders were bent in three point bending with the mid-span load and deflection being incrementally recorded. The resulting data were published in an internal RTA *Girder Rig Testing Report No. N150-GRT* (Law et al., 1992a) and some aspects were reported publically by Law and Morris (1992). From these data gained a linear regression line through each load-v-deflection curve was used to estimate the girder stiffness. The SMA was estimated from the external vertical and horizontal diameters of the girders, with the cross-section assumed to be elliptical in shape. In estimating these sections, defects such as piping, checking and rot were specifically not taken into account, neither were they recorded in the available parts of the N150-GRT report (Law et al., 1992a). The age of the girders was estimated by RTA personnel.

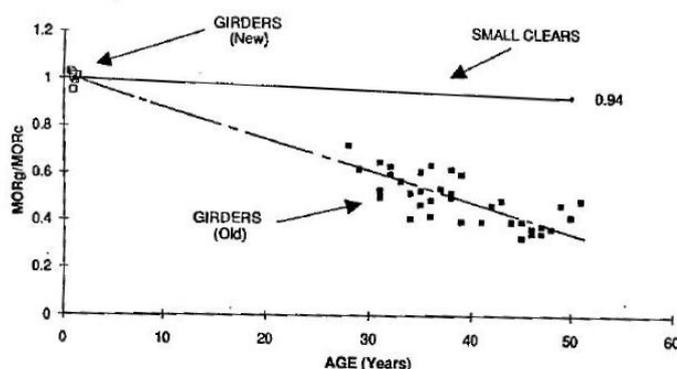
**Figure 2-20: Normalised MoR-v-Age,  
Source: Law and Morris (1992, Figure 5)**

Law and Morris examined these data from a design perspective and reviewed whether the AS 1720 and NAASRA Bridge Design Specification codes of the time correctly represented the required reduction factors for the MoR and MoE of aged girders. They concluded that the codes were not conservative. The Law and Morris data (Law & Morris, 1992, Figure 5) are reproduced here as Figure 2-20. The MoR data appear to be normalised according to the mean values obtained from new girders and the measured values of the aged girders cover a range of about 34% to 74%; representing a mean reduction of about 46%. Since there is no evidence that the normalisation levels are specified, the published MoR values cannot be interpreted in comparison with the MoE values.

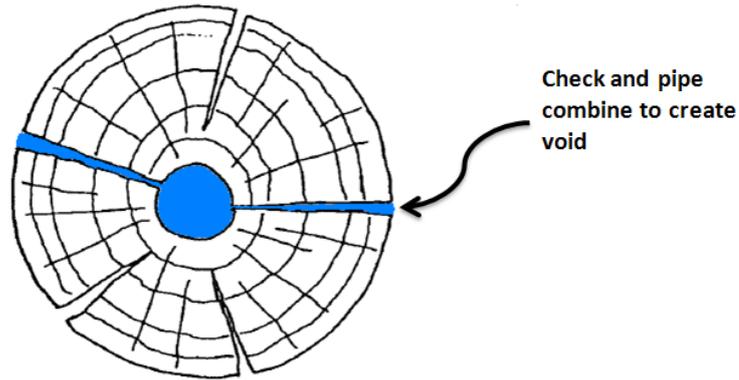
**Figure 2-22: A simplification of the combination of a check and a pipe, adapted from Yttrup, Law, & Subramaniam (1991, Figure 9)**

A well planned load testing of a bridge should recognize ‘lazy’ beams, see Figure 9 [reproduced here in modified form as Figure 2-22]. No amount of non destructive ultrasonic or x-ray methods will detect defects of this nature.

An example of the combined contribution of checks and pipes is shown in Figure 2-22. In this figure is shown how a central pipe can combine with two checks to cause the girder to separate into virtually two independent elements. The effect of this separation is significant as indicated by Moore (2009, A-103). In the case of a simplified equivalent rectangular beam, separation into two elements of equal cross-section reduces the MoE by a factor of the square of the number of elements, which is  $2^2$  or four. In a load test the load would have to be reduced by four so as to not exceed the deflection at which rupture occurs. It would thus appear that the girder MoR would be reduced by four when compared with an apparently similar looking, but intact, girder.

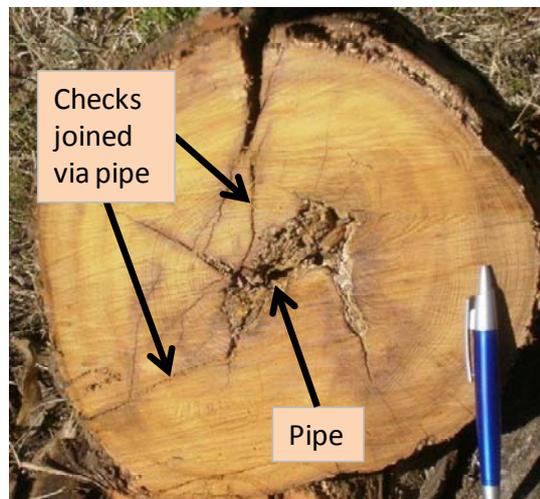
**Figure 2-23: Cross-section of timber with checks joined by an internal pipe (Photo courtesy R. Patterson)**

In Figure 2-23 an example network of two fine checks connecting an incipient pipe is highlighted. Because of the fine nature of this network it is not possible to visually assess their structural significance. There may well be significant connectivity across the checks, as shown in Figure 2-23, and if similar checks were present in the mid-span of a girder then they would be continually stressed and the connectivity would temporally vary.

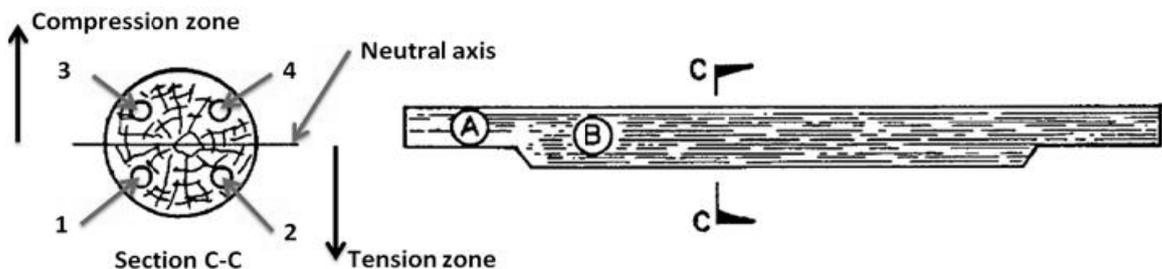
Figure 2-24: Diagrammatic simplification of girder and position of samples, adapted from RTA Report N150/06 (Law et al., 1992b, Table 3.1)

Once the girder tests were complete small clear samples were excised from areas A and B at locations 1 to 4, as shown in Figure 2-24, and each independently tested to determine the MoE, MoR and moisture content of each sample. It is cited in the RTA N150/06 report (Law et al., 1992b) that this work was carried out by Queensland Forest Service but their report was not available. Although some available documents identify that moisture content was recorded, there was insufficient work carried out to determine its effects. These data from these tests have survived, but detailed discussion was not able to be located.

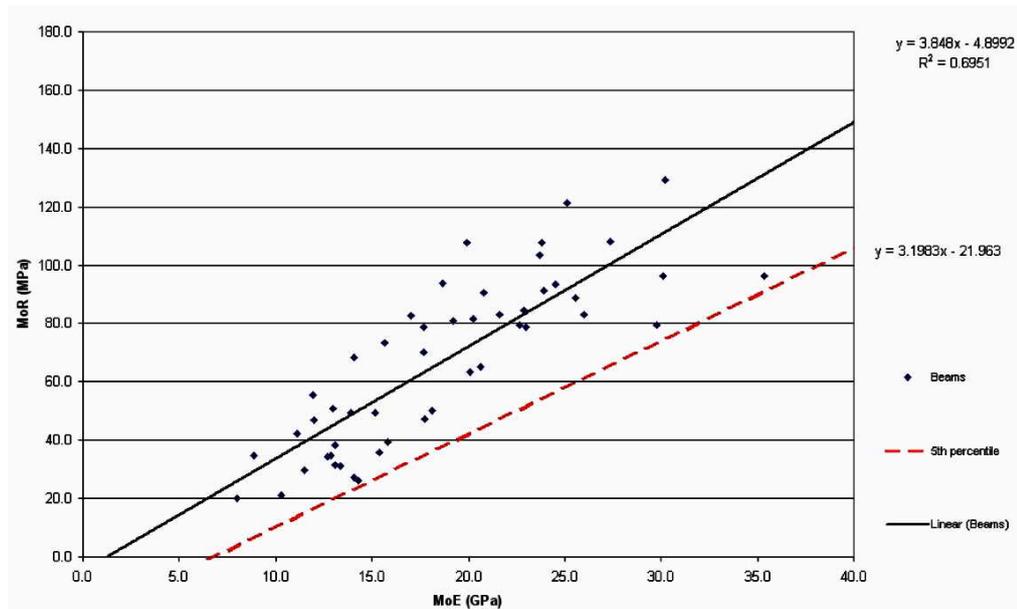
Figure 2-25: MoR-v-MoE scatter plot, Source Wilkinson (2008, Figure 4.7)

Wilkinson's interpretation of these data was from the design perspective using the results to guide the design of a laminated girder that was to be used to retrofit an existing solid round timber girder. The results of the bending tests of the round girder set were presented in two diagrams. The first was an MoR-v-MoE scatter diagram, as shown in Figure 2-25 (Wilkinson, 2008, Figure 4.7). The second was an MoR-v-Condition State scatter diagram, as shown in Figure 2-26 (Wilkinson, 2008, Figure 4.9). The slope of the MoR-v-MoE regression line is reported as 3.8 but no significance is given to this value by Wilkinson. It will be shown in Chapter 3 that a slope of about this magnitude is typical for timber girders. The coefficient of determination for the sub-set in Figure 2-25 was quoted as 0.6951 and a fifth percentile curve identified (Wilkinson, 2008, Figure 4.7). Wilkinson did not discuss the MoR-v-MoE vector trajectory of an individual girder and only provided the observation that MoR generally declines with condition state as shown in Figure 2-26 (Wilkinson, 2008, Figure 4-9).

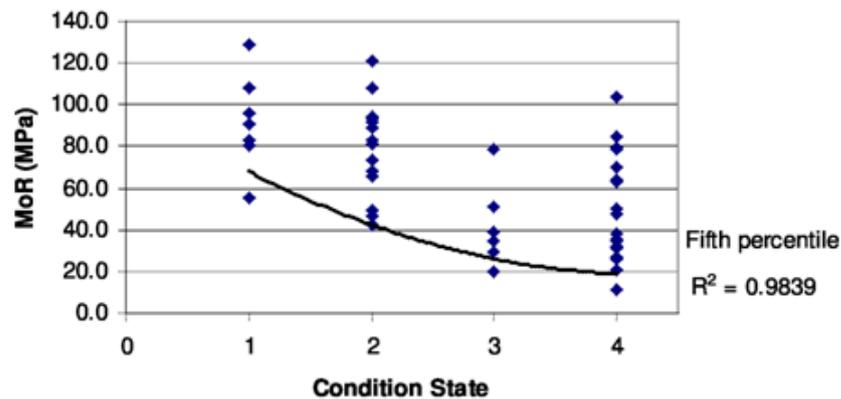
Figure 2-26: MoR-v-Condition status, Source Wilkinson (2008, Figure 4.9)

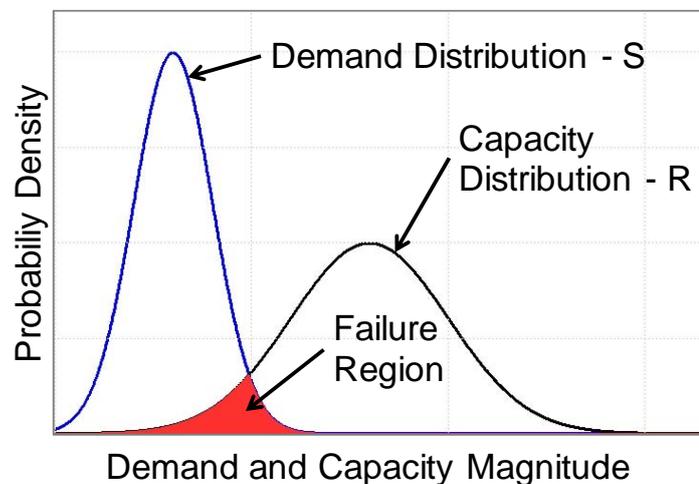
Figure 2-27: Schematic of typical demand and capacity distributions

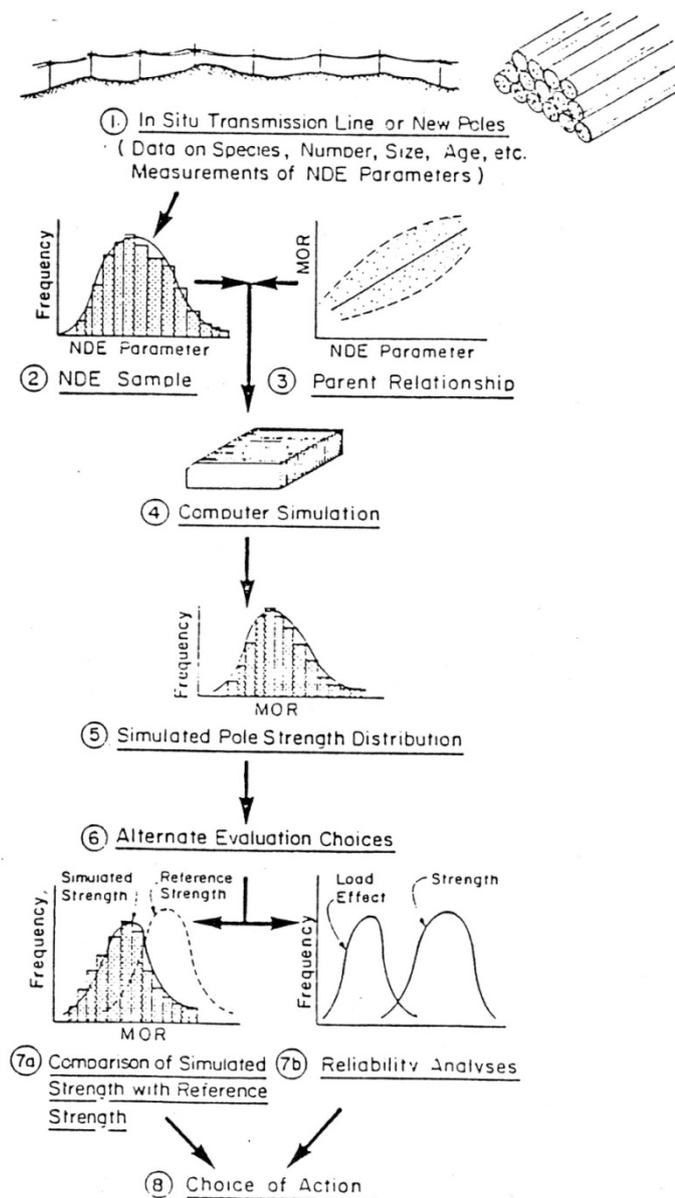
Figure 2-28: Reliability assessment procedure to evaluate timber poles (Bodig, 1985)

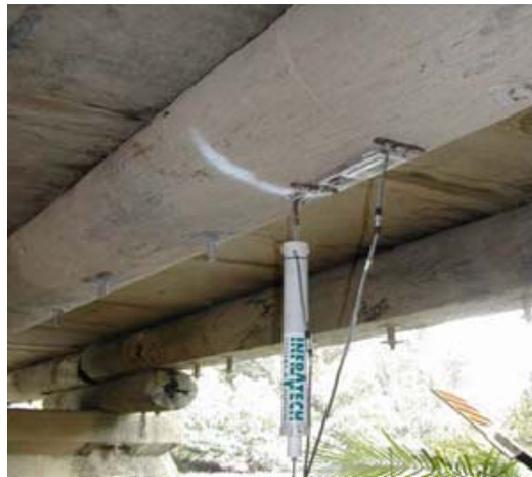
**Figure 2-29: Strain gauge and LVDT in experimental use on a timber-bridge girder (Heywood et al., 2003)**

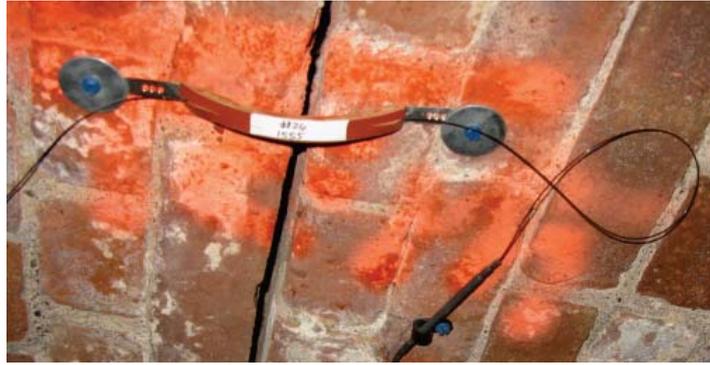
**Figure 2-30: Crack sensor on masonry vault arch of Brooklyn Bridge, New York, adapted from Talebinejad et al. (2010)**

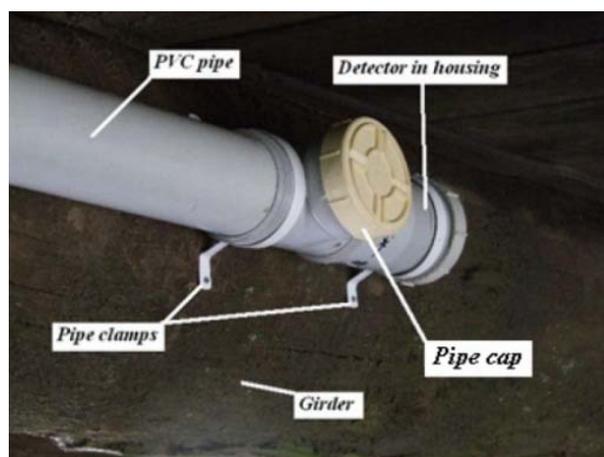
Figure 2-32: Detector mounted at girder mid-span (Moore, 2009)

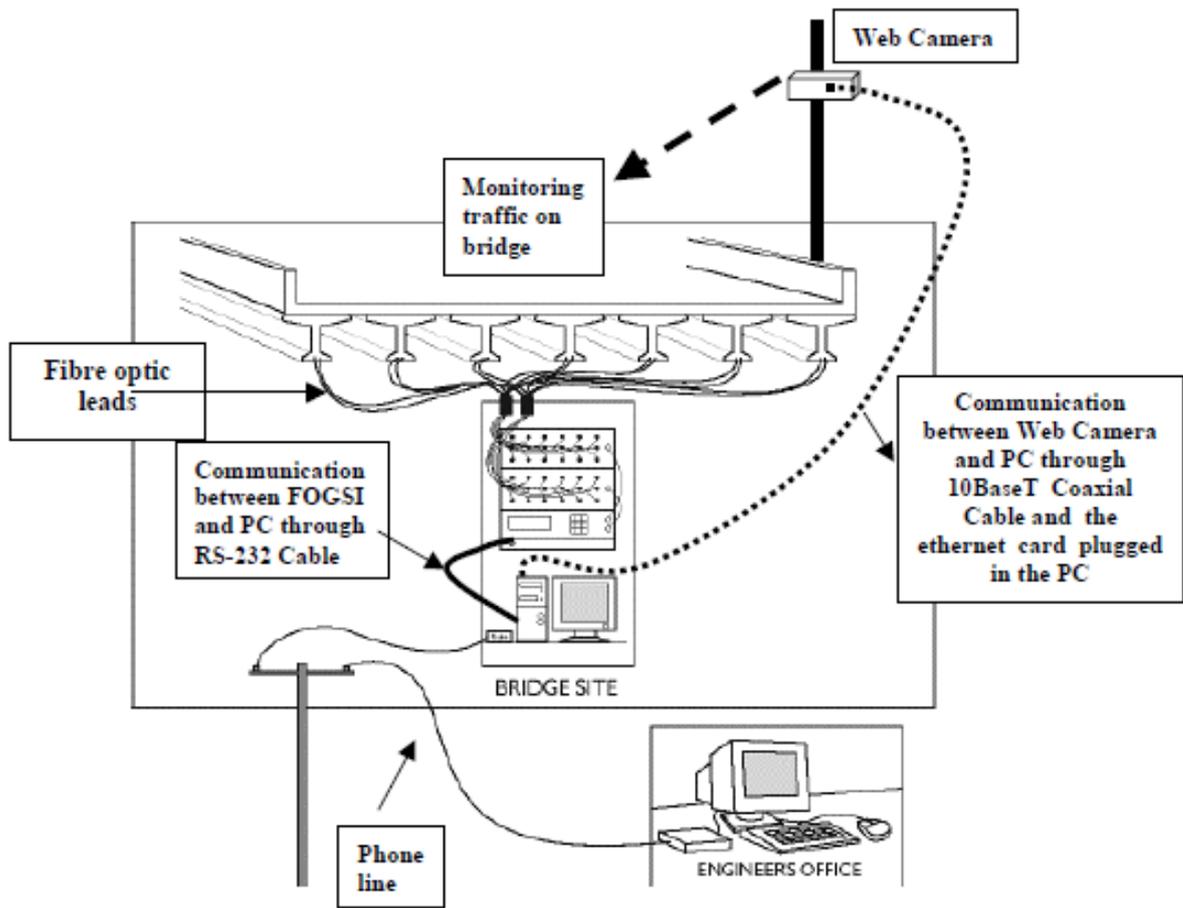
Figure 2-33: Layout of monitoring systems in Taylor Bridge, Provincial Road No. 334, Manitoba, Canada (Mufti, 2001: Section 6.6.1)

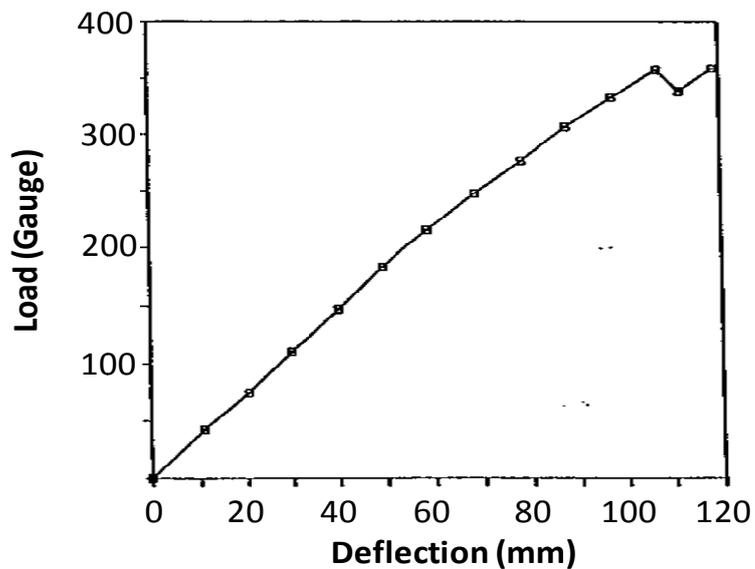
Figure 2-35: Load-v-deflection response for a DS-2 sample girder, adapted from Law et al. (1992a)

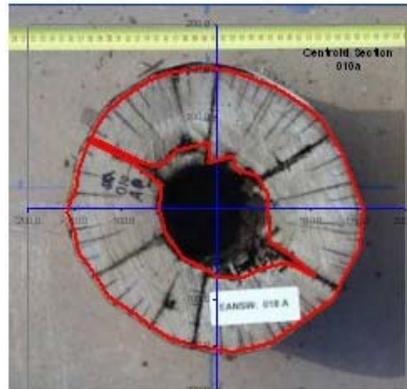
**Figure 2-36: Cross-section of a power pole showing extensive piping and checking (Crews, 2005)**

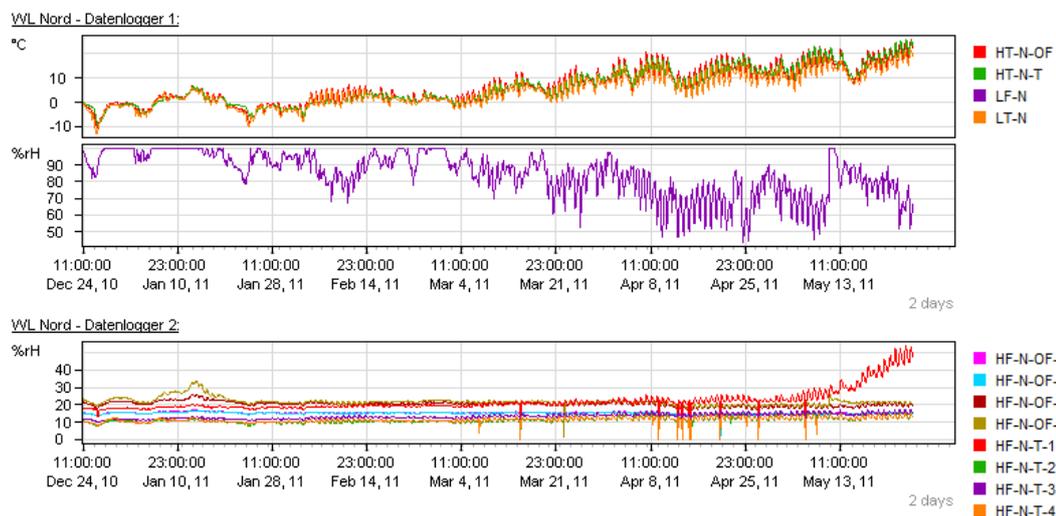
**Figure 2-37: Typical MC of timber-bridge components (Tannert et al., 2011)**

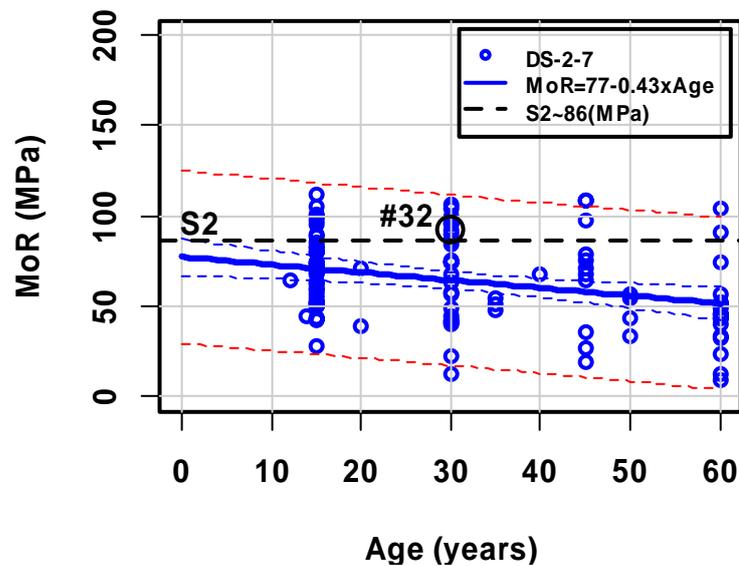
Figure 3-15: DS-2-7 regression of MoR-v-Age; also girder #32 (black point) and S2 limit (dotted black line)

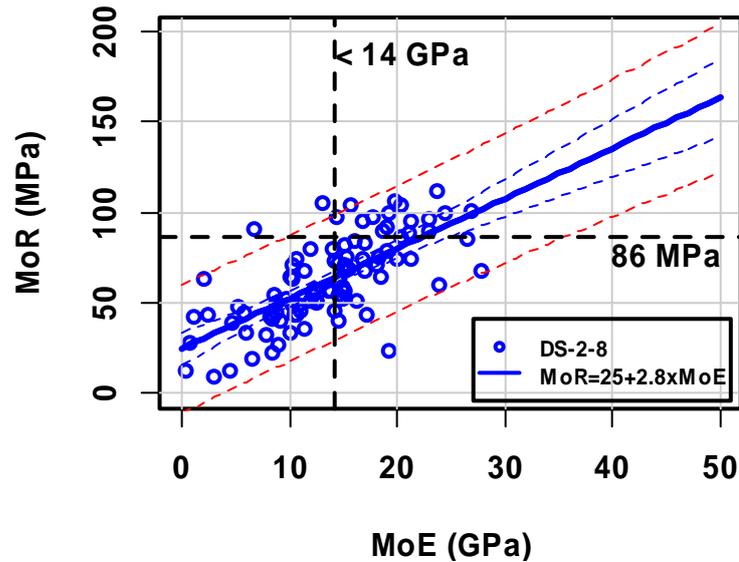
Figure 3-16: DS-2-8 regression of MoR-v-MoE

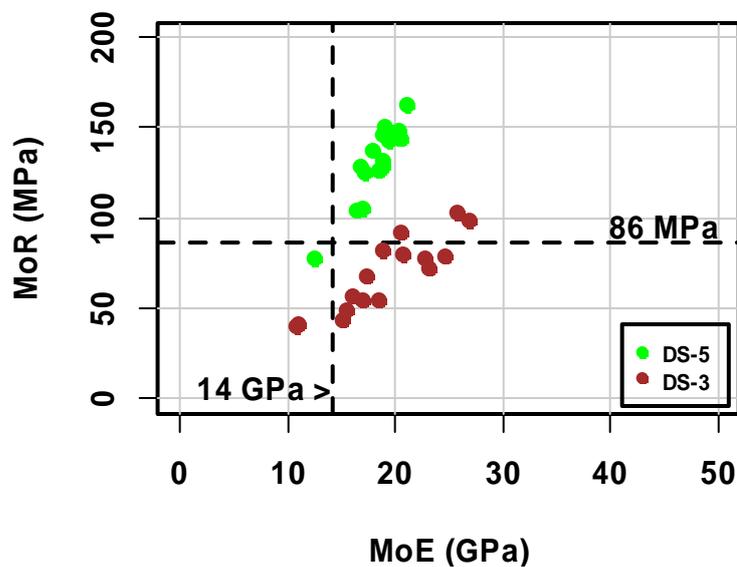
Figure 3-21: DS-3 and mean DS-5 MoR-v-MoE scatter plot

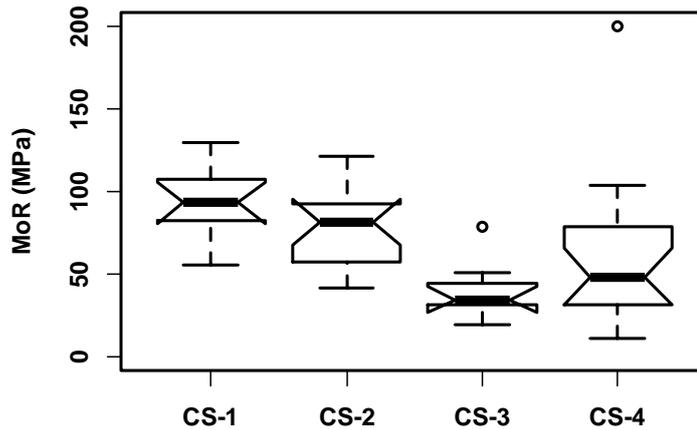
Figure 3-26: Box plots summaries of DS-4 MoR as ranked by condition state CS-1 TO CS-4

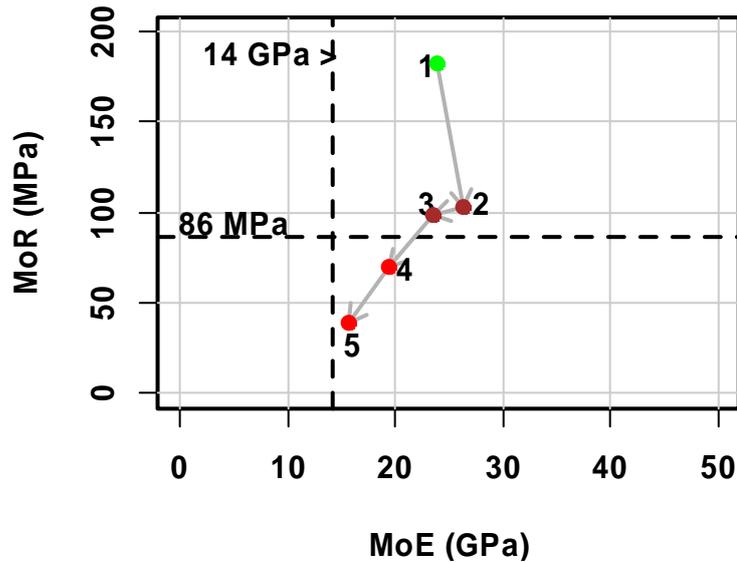
Figure 3-29: DS-4-6 Ironbark degradation vector path (points 1-5, refer Table 3-12)

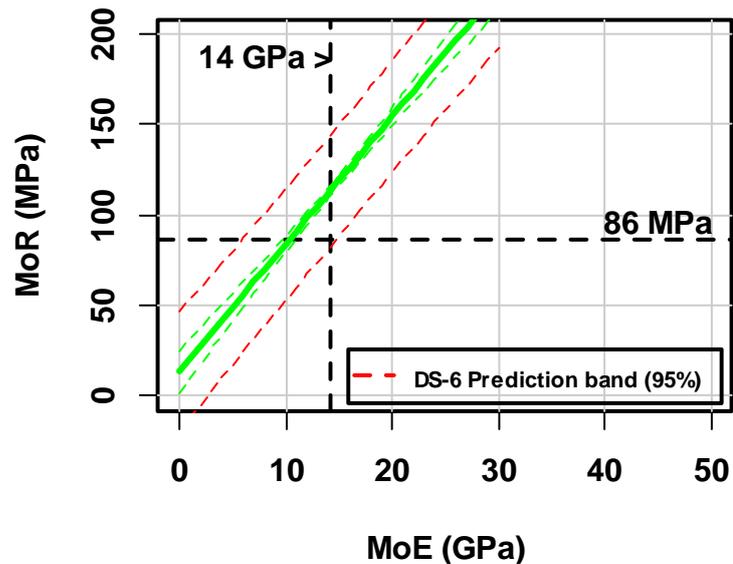
Figure 3-34: DS-A regression and prediction limits

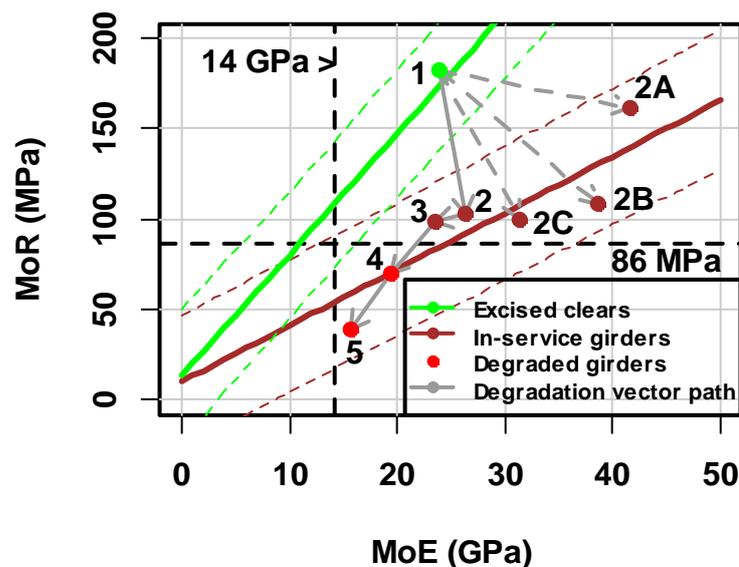
Figure 3-55: Degradation vector path overlaid on MoR-v-MoE regressions for DS-1 to DS-4 and DS-5 & DS-6

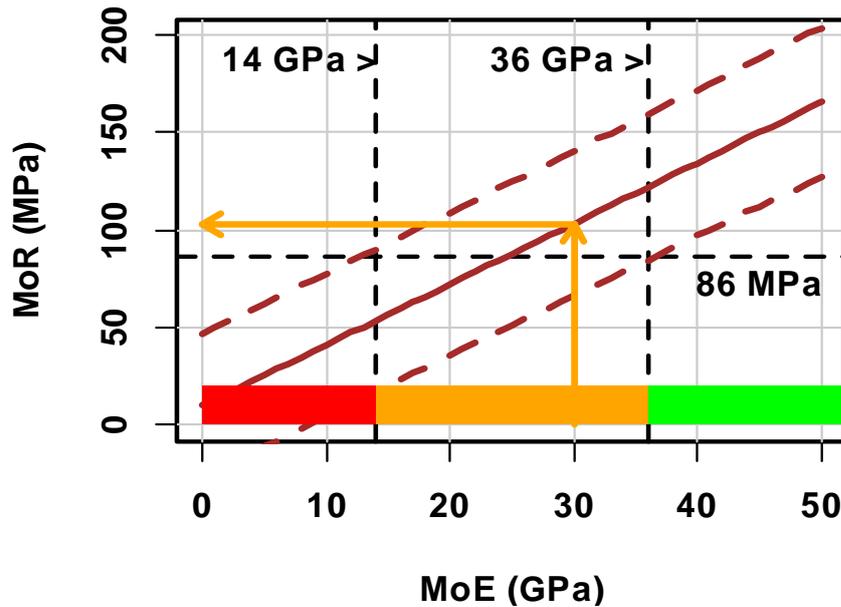
**Figure 3-56: Example of using MoE to predict MoR**
