## **Appendix C-4                      Central Residential Zone 4 (CR)**

**Historical archaeology at a French colonial hill station in Central Vietnam:  
Bạch Mã 1930-1990**

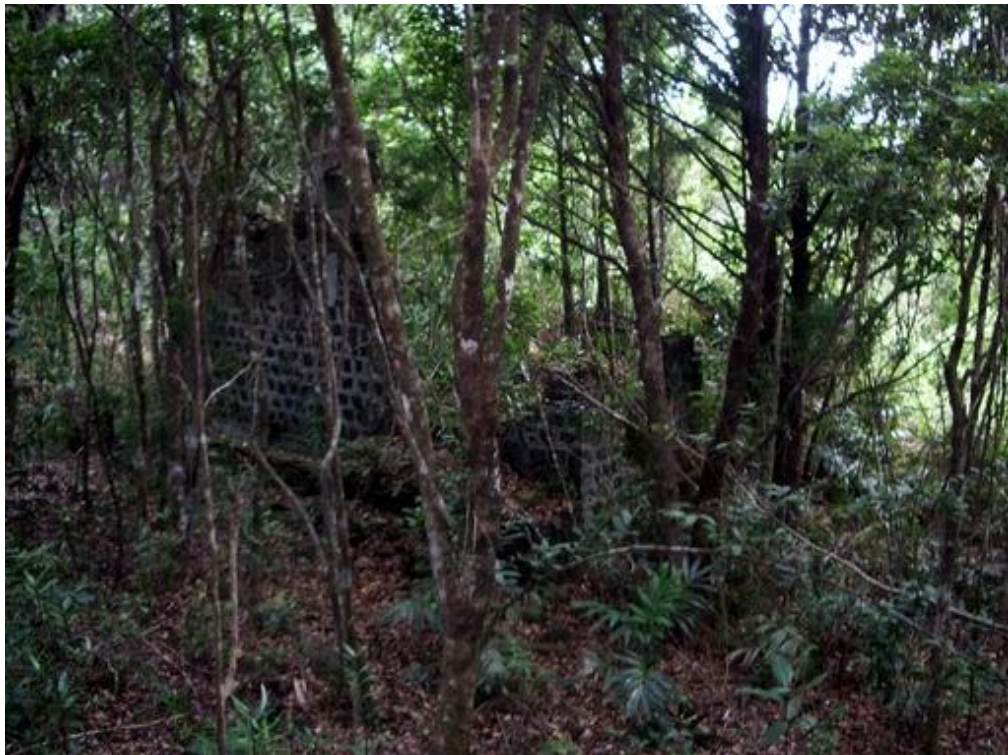
**Figure C- 73 CR HS8, Harter, Lots 39,41, north-eastern corner.**

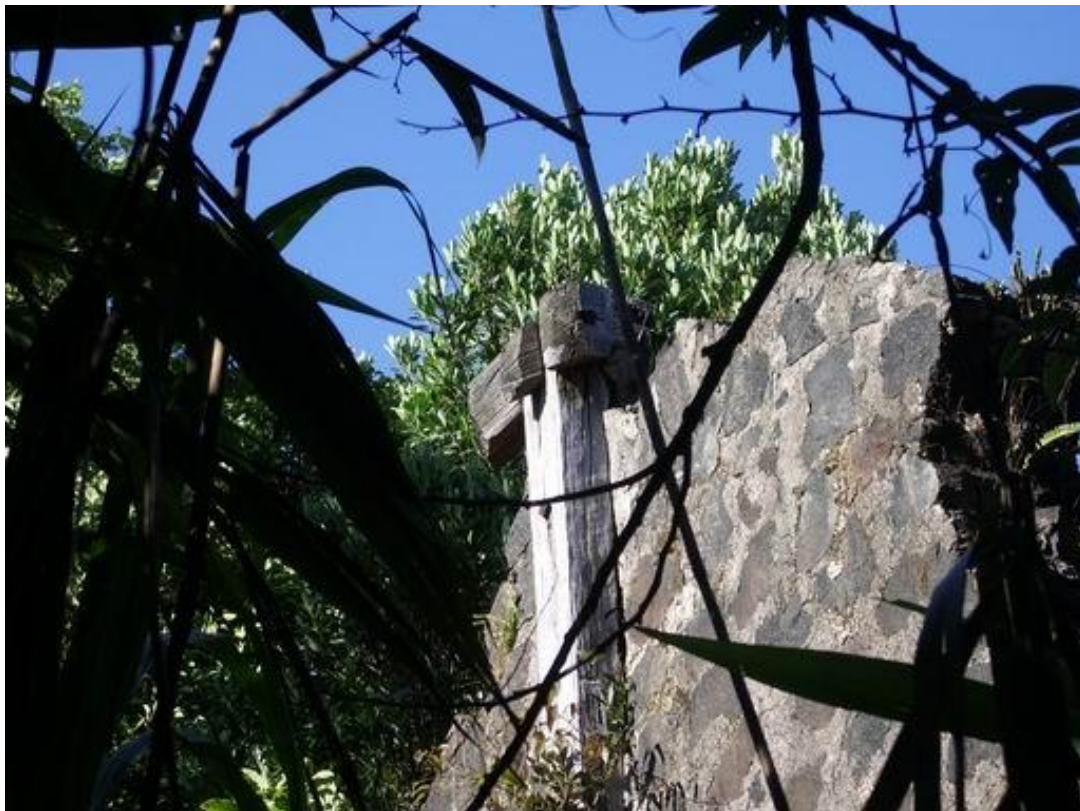
This site is located in the main part of the Central Zone. It consists of a stone main building with sections of some walls still standing to 6 metres high. Distinctive is the remains of large roofing timbers, apparently cut off to salvage (see Figure ). Type 5 roofing tiles.

Figure C- 76 CR HS12, Thân Trọng Khôi, the roof beams have been cut for removal

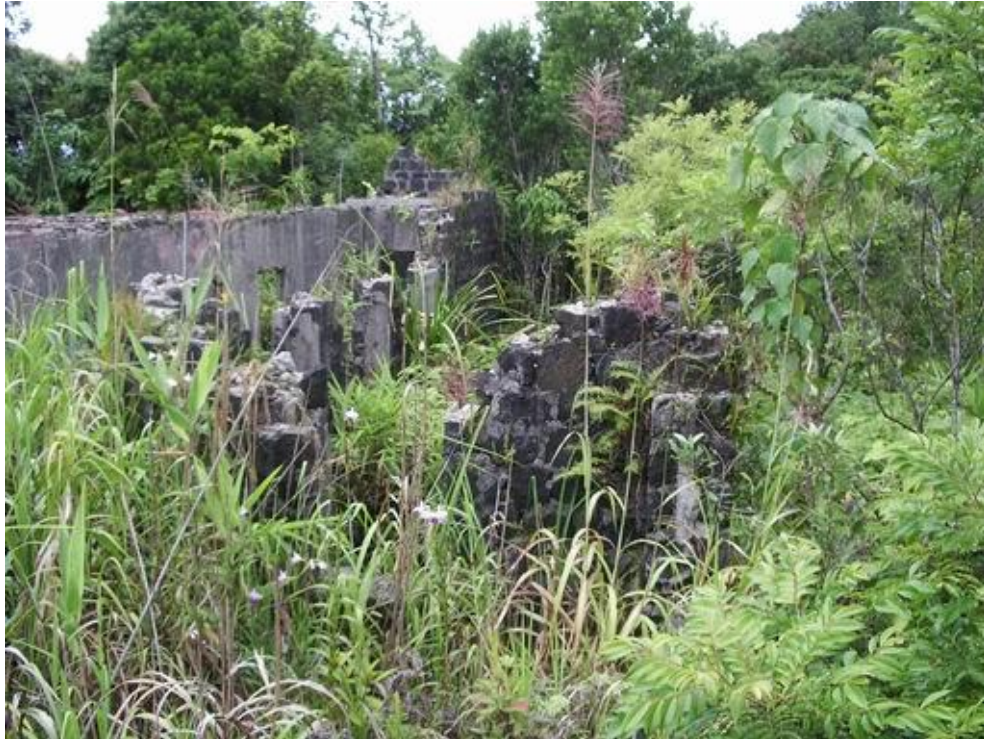
This site is on a ridge running southwest from the forested summit of Nui Bạch Mã. The villa was a substantial stone structure, extensively damaged. Unable to be mapped because it was also heavily overgrown.

**Figure C- 79 ER HS6 Jouffrey lots 80-81 Looking across site from northwest corner.**

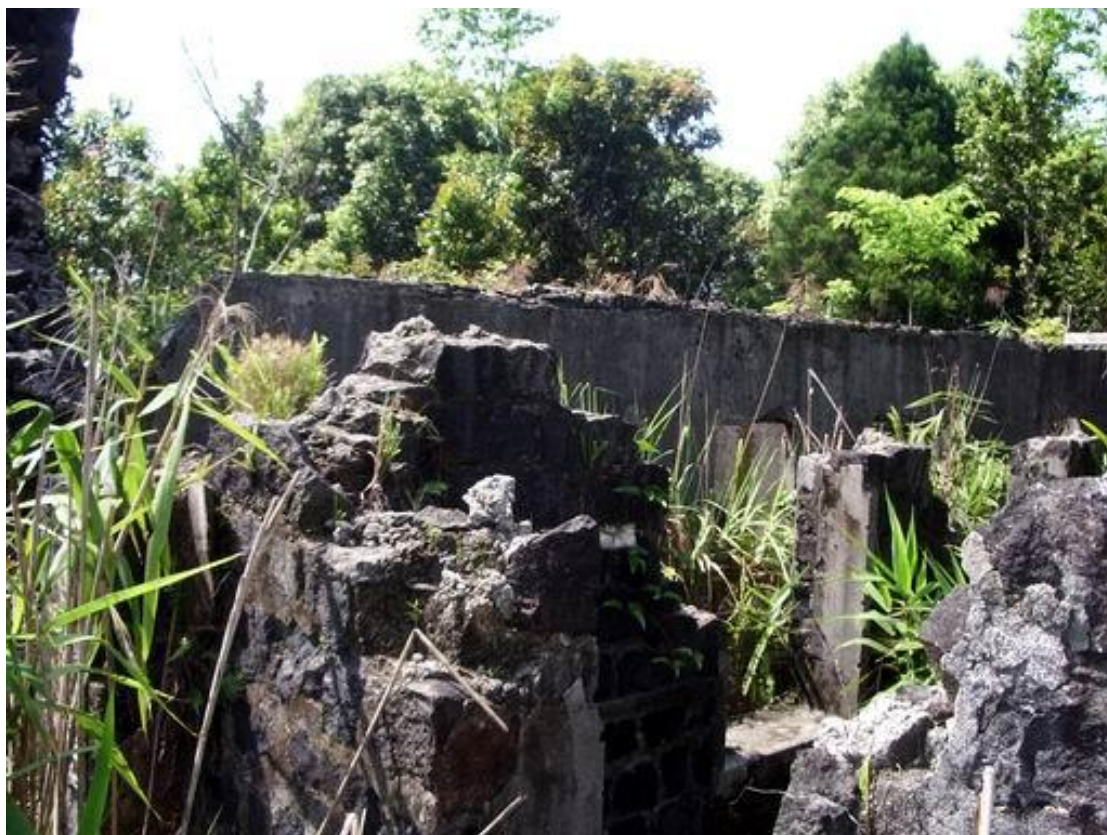
**Figure C- 81 ER HS7 Armée No lot number**

This site is adjacent to ER HS6, a little higher on the same ridge. Similarly unable to record because it was extensively overgrown.

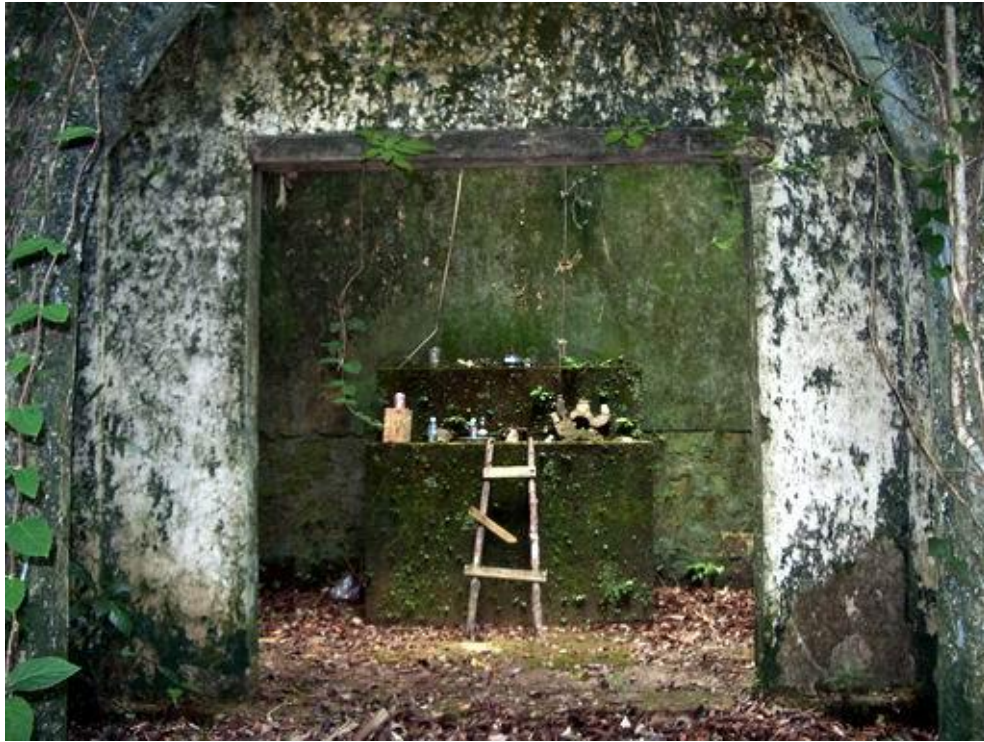
This structure of brick and concrete on a granite foundation is located about 20 metres above the main access road. It is substantially intact except for the roof. It is a typical Vietnamese Buddhist temple layout with access through 5 arched doorways onto a covered verandah, and three doors into the main room. Three alters are positioned along the rear wall. Type 2 roofing tiles are scattered around the floor. Within the main building two fragments of kitchen ceramic were located. One of these included the trademark 'HB.CM – France (see Figure 7-4). Another piece of red, very fine grained, glassy material (40x15x21) was also located (see Figure 7-5).

**Figure C- 82 WR HS2, Buddhist Temple, view from outside looking at central alter. The temple is regularly visited by some BMNP summit staff.**

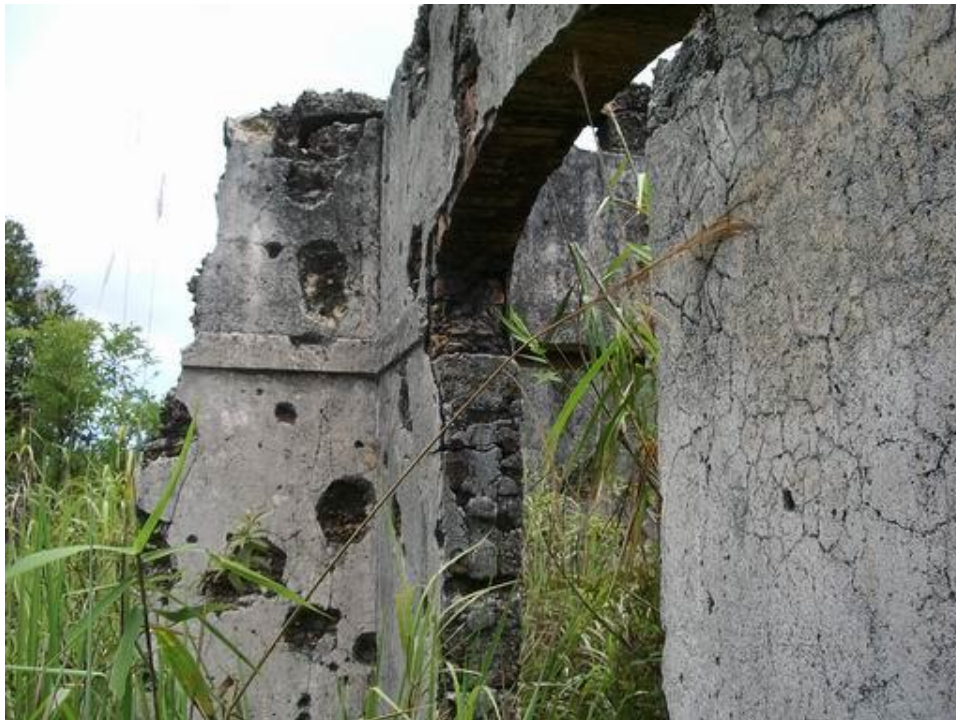
Located on a spur below the north-west ridge, this site has a prime location with substantial views to the north-west and south. The concrete structure is fairly symmetrical, appears to have four main bedrooms with a large common central living area, each with access to its own bathroom and toilet, however the two rooms on the south-west have internal access to bathrooms, while at the other end access is external. The southern wall had many bullet holes on the outside. About 6 metres north of the house two poles and a scatter of roofing tiles suggests another structure in the garden area. No internal kitchen facilities noted.

Figure C- 83 WR HS4, Lot 76. Note damage in walls from gunfire.

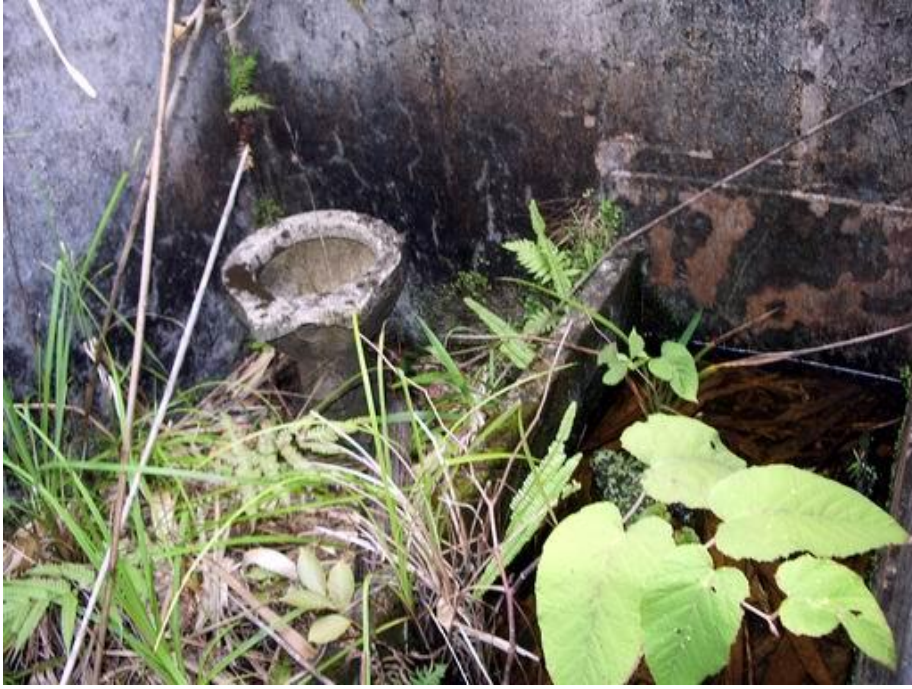
**Figure C- 84 WR HS4, Lot 76. Bathroom on southeast corner**

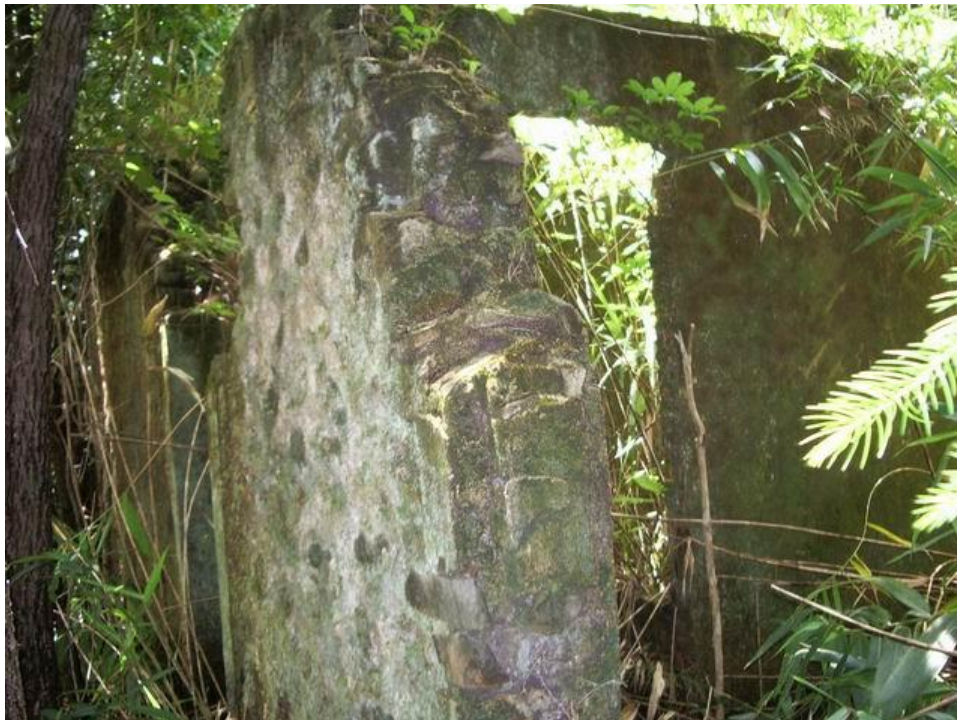
Figure C- 85 WR HS5, Lot 75

This site is located in a saddle below WR HS4. Walls of main villa are largely intact, however, a concrete slab on the southern side suggests another building now destroyed. Probably had bathroom facilities inside the main house. A small service building to the south-east of main house also has a pit that suggests a toilet. Type 9 roofing tiles. A small stack of roofing tiles were noted near the access to the site from the road as well as a pile of stones adjacent to the main house.

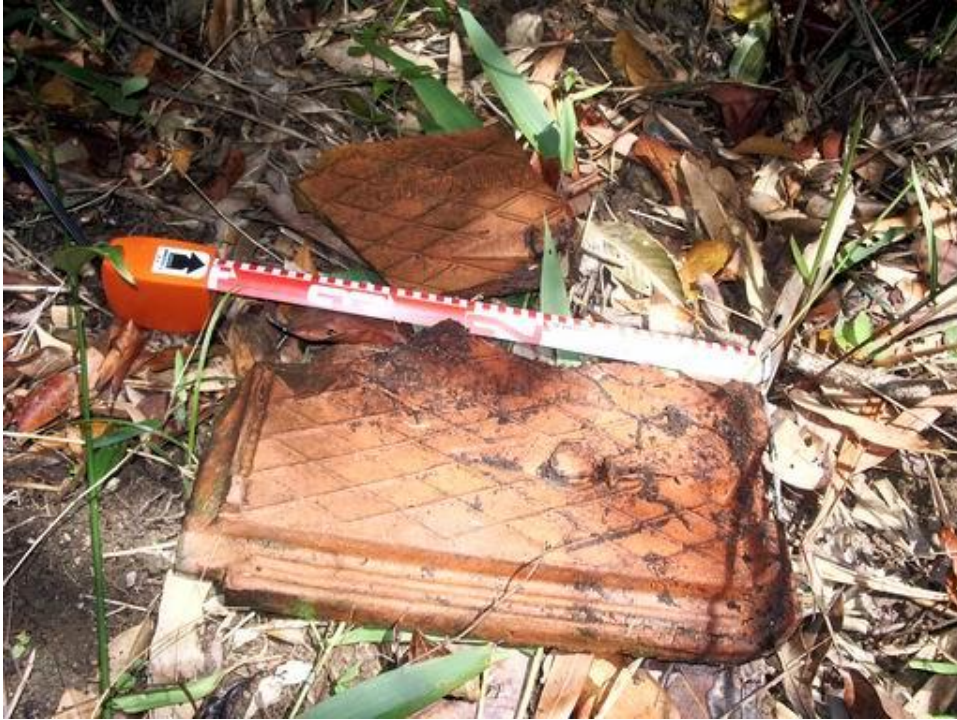
Figure C- 86 WR HS5, Lot 75. Example of roofing tile. This is a Chu Van Luan (Type 9) tile

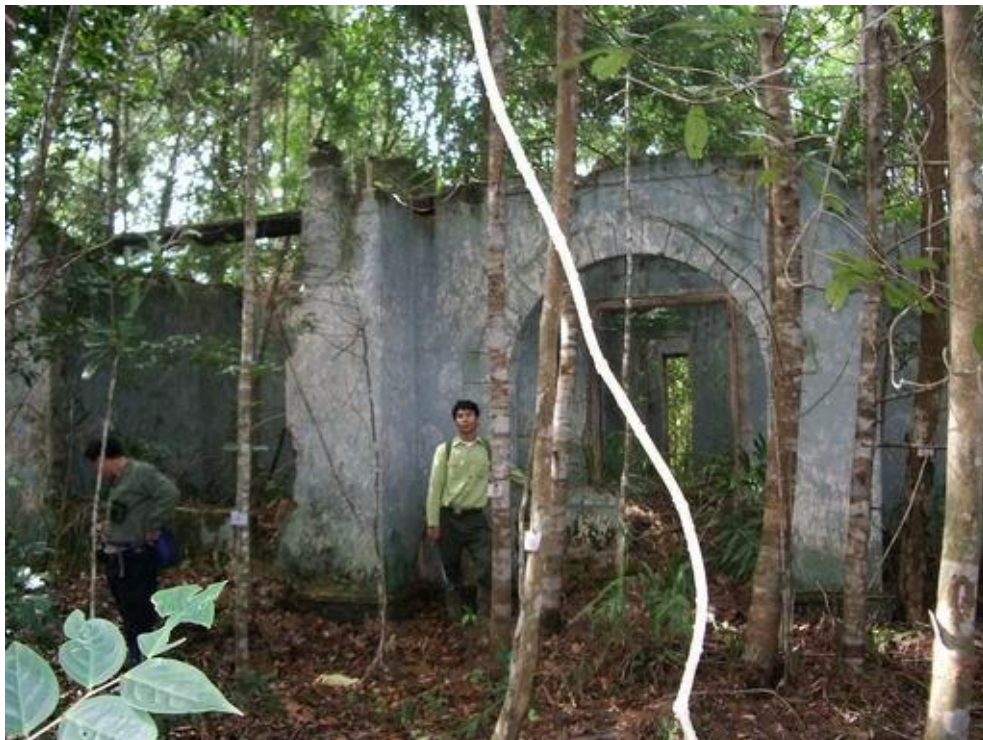
Figure C- 87 SR HS1, Diu. Note the arched entry onto covered verandah

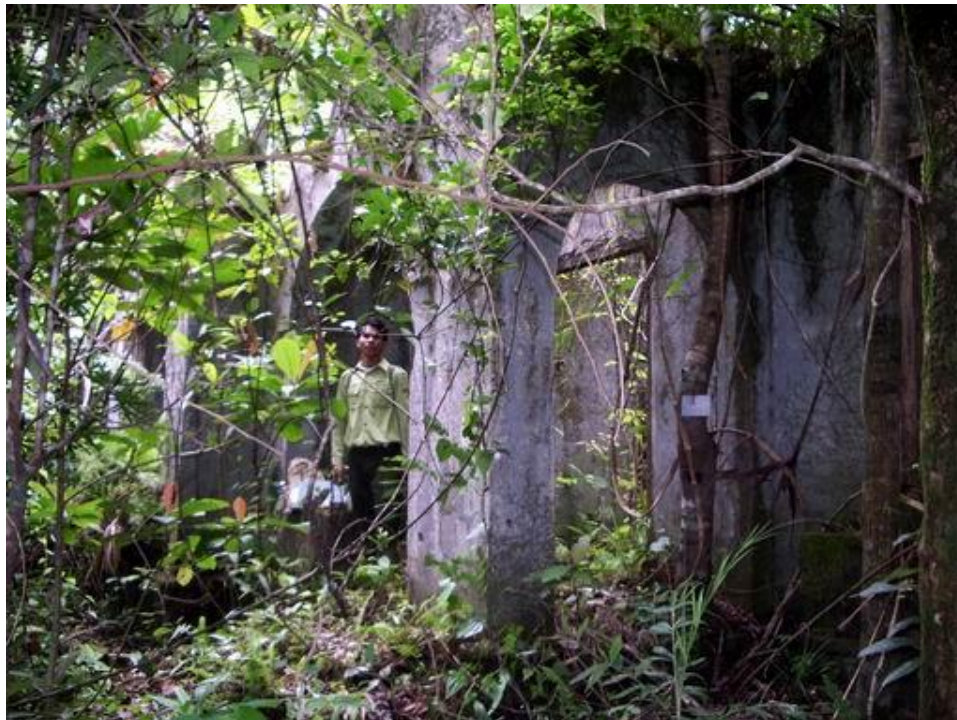
Access to this site during the field survey was from a small gully in which a small scatter of 5 pieces of kitchen ceramics and a piece of glass was collected. The villa was relatively intact and notable for having most of the window and door frames intact. A fireplace in the living room had a slow combustion door in place. Possibly a room in the roof cavity but no stairs noted. No roofing tiles noted.

Figure C- 88 SR HS3. Note the similar entry and house layout with SRHS1

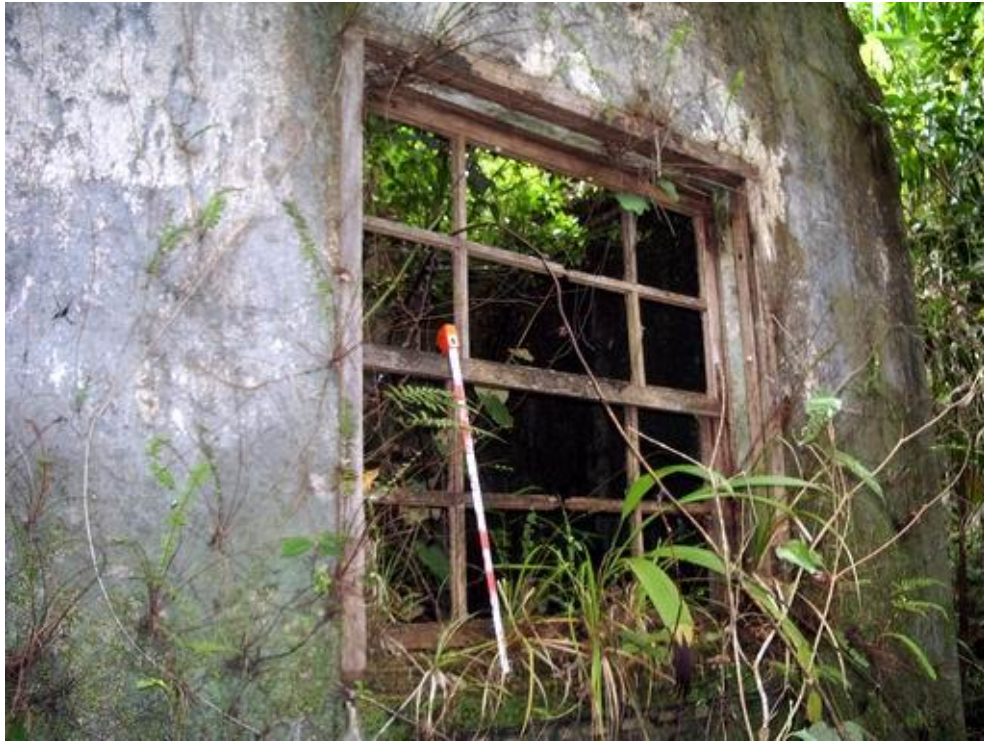
**Figure C- 89 - 40 SR HS3, No name. Several structures in the southern zone retained some window and door frames**

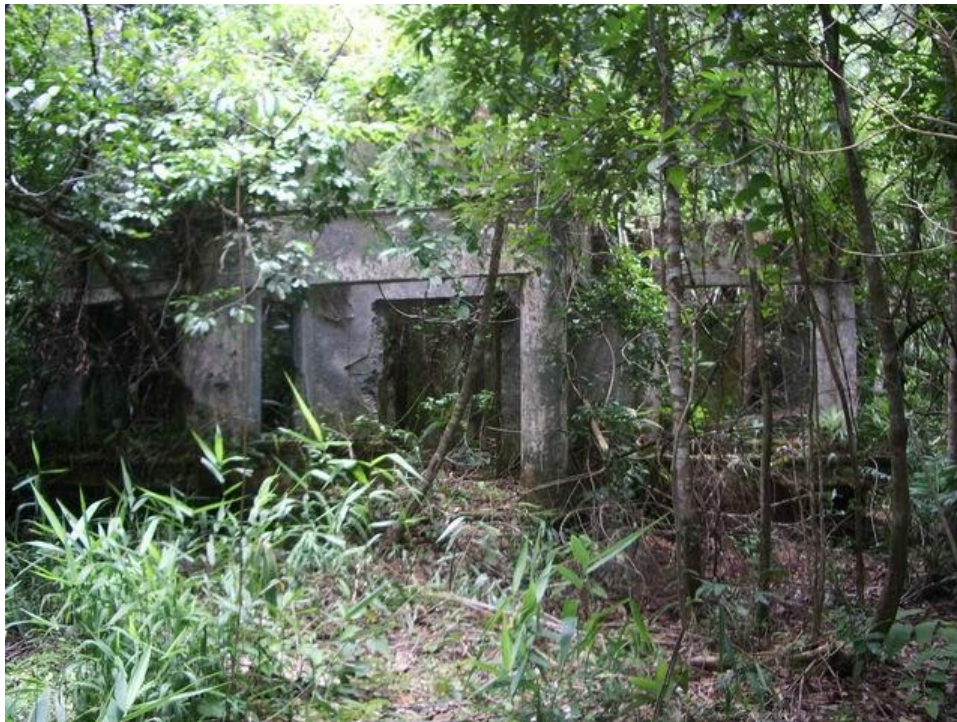
A large building with concrete walls, pitched roof and Type 6 roofing tiles. Two internal bathrooms. The secondary building has 3 rooms, one a kitchen, as well as a small toilet and kitchen on the end of the structure. Four pieces of brown ceramic storage jars were found outside the house. Sogny was the local head of the Sûreté or secret police.

Figure C- 91 SR HS8, Sogny. Note the column marking the entry onto a covered verandah. To the right is a large window looking out from the main living room.

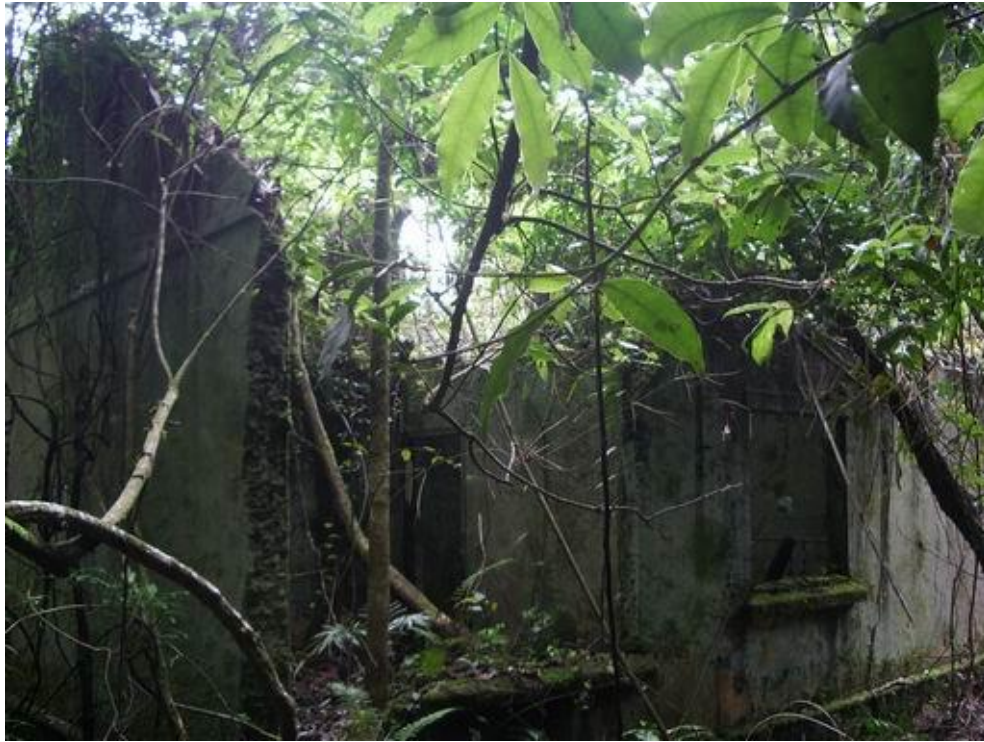
**Figure C- 92 SR HS8, Sogny. The southwest corner of main building**

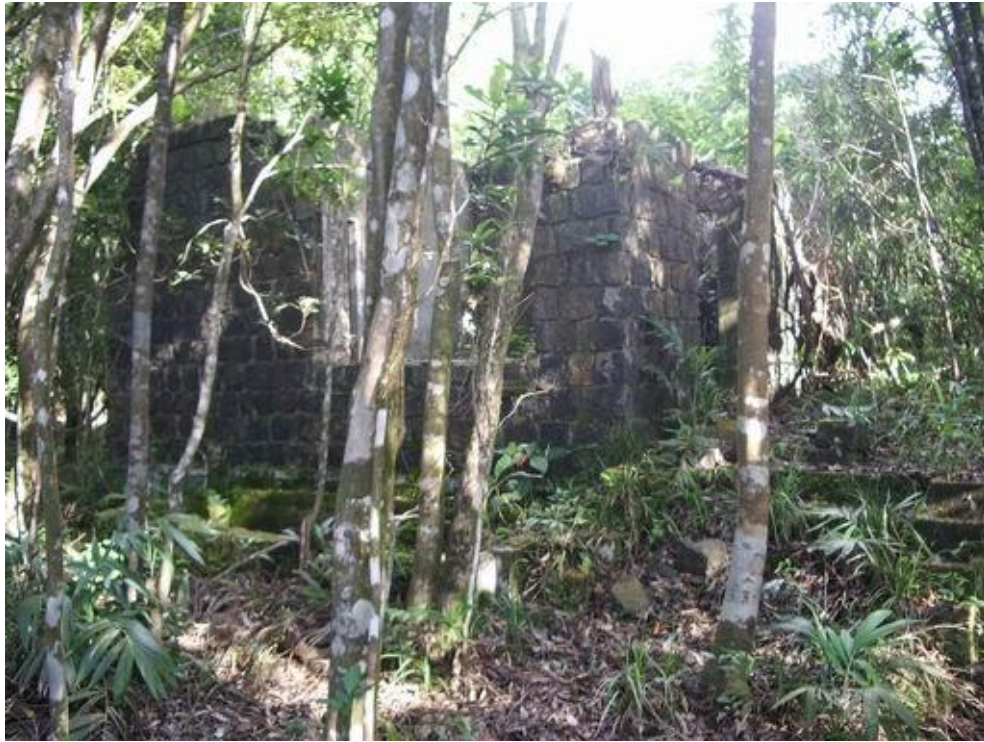
**Figure C- 93 SR HS11, Thua Thien Residence, southeast corner of main building.**

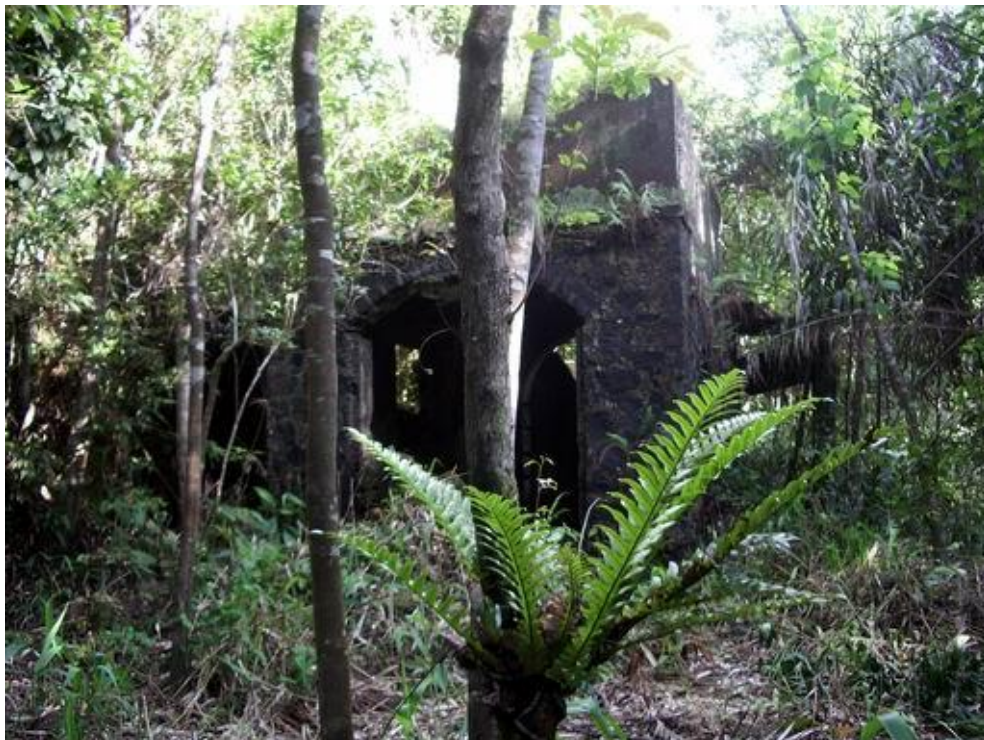
**Figure C- 94 SR HS11, Thua Thien Residence, apparently a garage with further accommodation above**

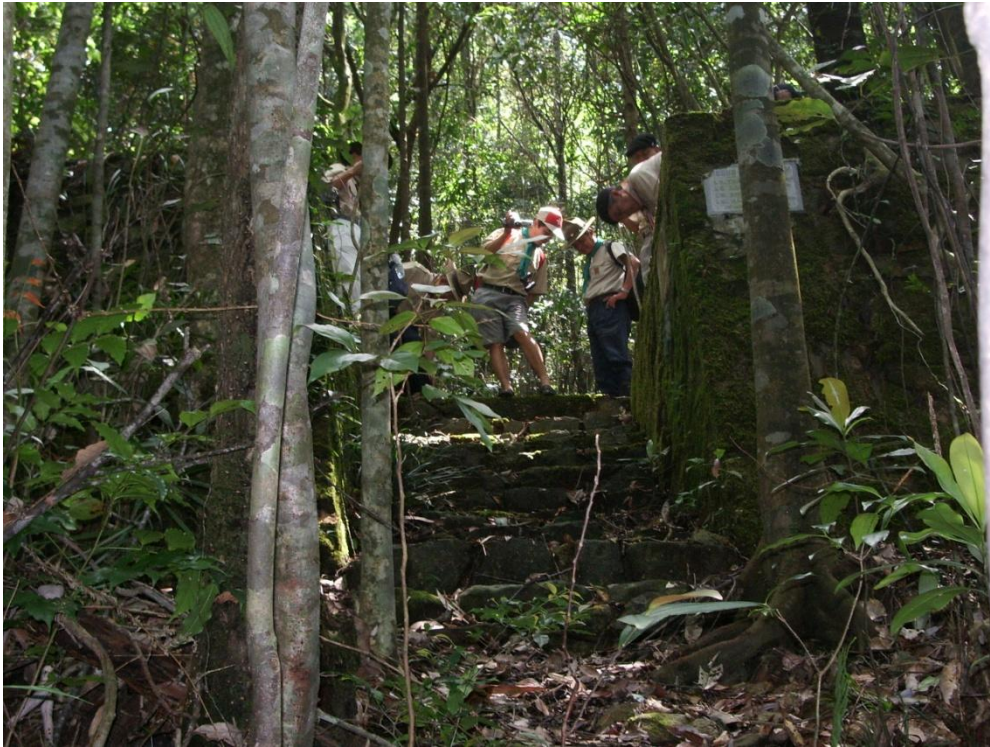
Figure C- 97 A stairway leads up through the stone retaining wall to the flagpole site, 2007

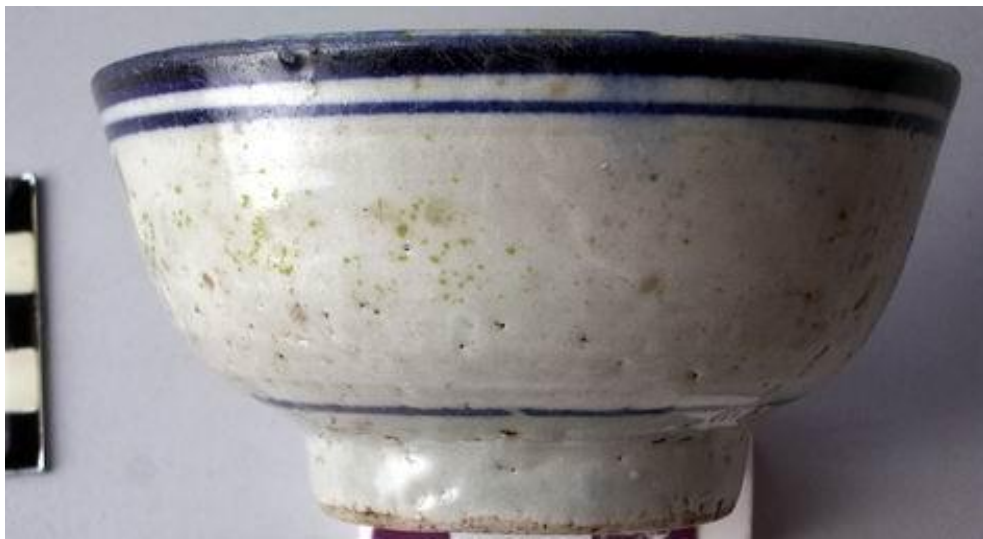
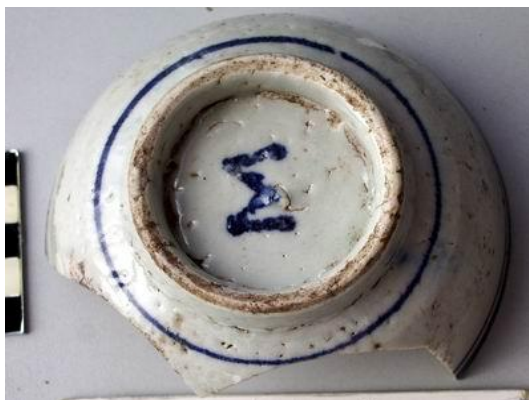
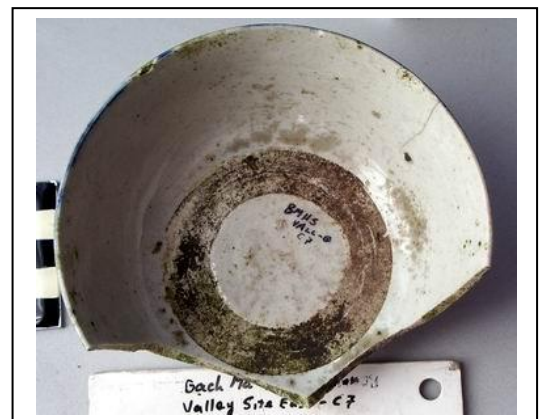
Figure D- 45 Type 3 bowl found in the valley east site and at two other locations in OBM

Type 3 bowls are blue on white glazed with a distinctive Roman ('M' or 'B') character inside the foot. The design on the outside of the bowl is a simple ring below the rim and above the foot. Examples of Type 3 bowls were found in the Valley East site, the Vietnamese market and the Hotel Bany site.

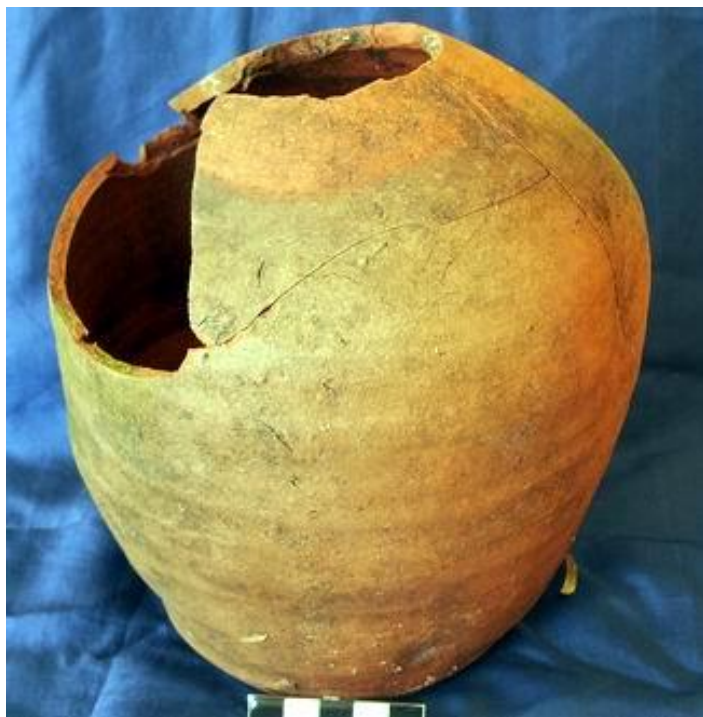
**Figure D- 49** 5LFS2C1 was located on one of the platforms at the Five Lakes farm site.

Only five earthenware items were recorded. 5LFS2C1 was found at the southwest farm site while CRHS1C1 was found adjacent to one of the ruins in the central residential zone.
